**Summary of Boat and Dive Monitoring at Boat Landings for
Eurasian Water Milfoil (*Myriophyllum spicatum*) on
Pipe Lake (WBIC: 2490500) and North Pipe Lake (WBIC: 2485700)
Polk County, Wisconsin - Summer 2010**

Project Initiated by:
Dick Hollar; Pipe Lakes Protection and Rehabilitation District

Landing Monitoring Conducted by and Report Prepared by:
Endangered Resource Services, LLC
Matthew S. Berg, Research Biologist
St. Croix Falls, Wisconsin
October 23, 2010

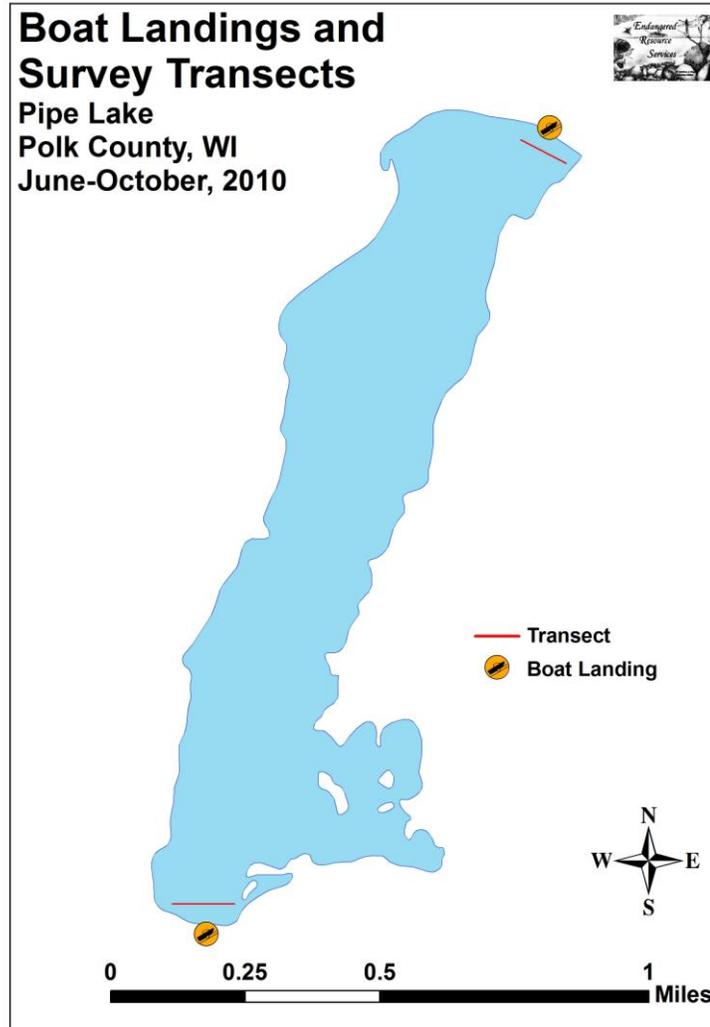
Figure 2: Boat Landings and EWM Survey Transects 2010

During the five months from the June-October 2010, we conducted landing inspections at least once a month at the north boat landing and the “unofficial” south landing on Pipe Lake (Figure 2). If conditions allowed (not raining and/or no people present swimming in area), we initially conducted a boat survey of the area. Using three 100-150m parallel transects approximately 15, 30 and 45m from shore; we motored at idle speed looking for any evidence of EWM’s characteristic red growth top. Once we had finished the three transects, we returned to our starting point using a stitch pattern that crossed back and forth over all three lines to look for any plants we may have missed between the transects.

During the summer of 2010, we conducted six transect surveys on June 6th, July 8th, July 28th, August 24th, September 7th and October 2th, and shoreline surveys on June 6th and October 2nd. We did not find EWM or any other aquatic invasive species in or adjacent to Pipe Lake. Water clarity started the summer as usual, but fell as the summer went on making for more challenging search conditions. During the August survey, I was accompanied by six other student divers and we did some training after searching the landing area (as this was a student trip, we worked as volunteers and did not charge the

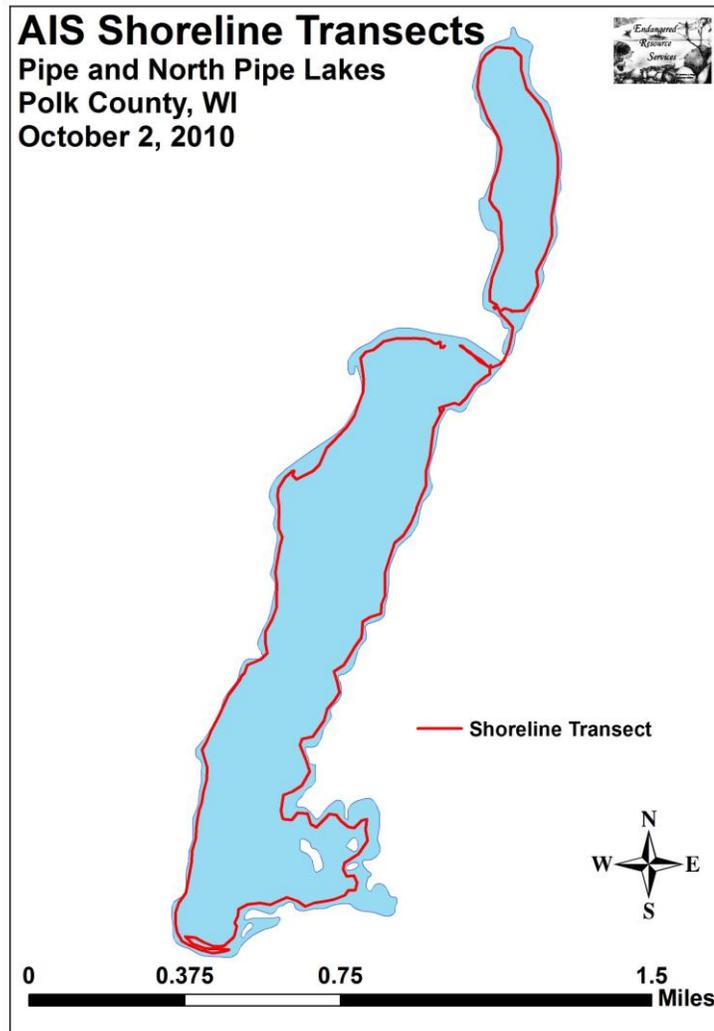
Figure 3: October Shoreline AIS Survey 2010

Water levels at Pipe have fallen dramatically since 2007, but a summer of rain has brought the water back up at least a foot. This influx of water is the likeliest reason for the loss of clarity we observed. One benefit of the higher water level was we were able make it into North Pipe Lake during our final visit of the year. Because of this, we extended our shoreline transect survey to include both lakes on the October 2nd visit (Figure 3).
