**Summary of Monitoring at Boat Landings for  
Eurasian Water Milfoil (*Myriophyllum spicatum*) on  
Pipe Lake (WBIC: 2490500) and North Pipe Lake (WBIC: 2485700)  
Polk County, Wisconsin - Summer 2011**

Project Initiated by:  
Dick Hollar; Pipe Lakes Protection and Rehabilitation District

Landing Monitoring and Shoreline Surveys  
Conducted by and Report Prepared by:  
Endangered Resource Services, LLC  
Matthew S. Berg, Research Biologist  
St. Croix Falls, Wisconsin  
June-October, 2011

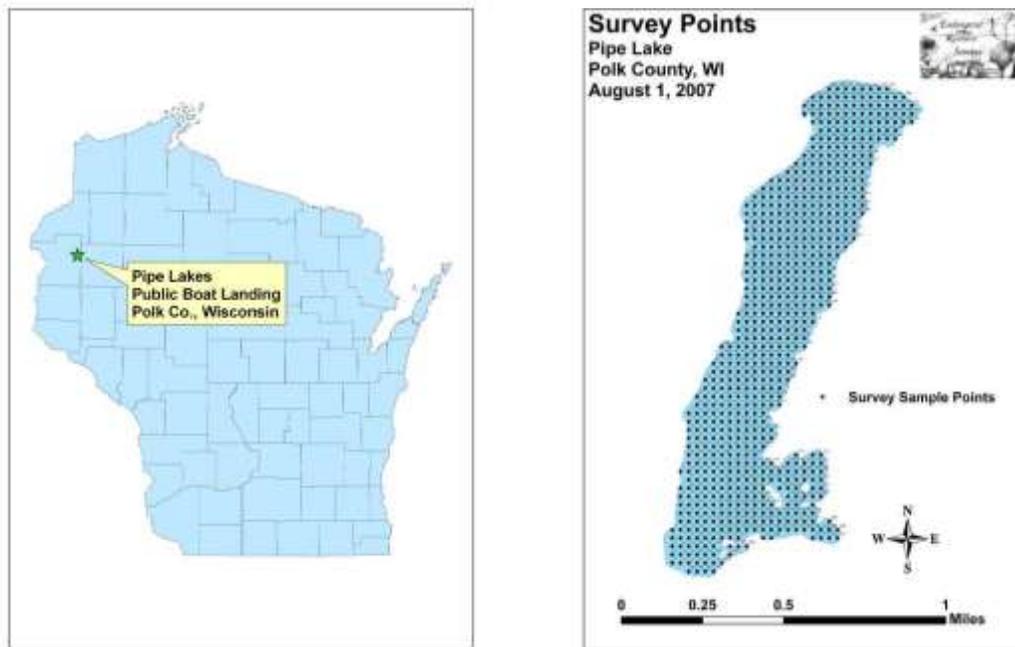
**Figure 1: Pipe Lakes, Polk Co., WI and Point Intercept Points 2007**

During the summer of 2007, an extensive point intercept plant survey found there was no Eurasian water milfoil (*Myriophyllum spicatum*) in the Pipe Lakes (Figure 1). As part of completing an Aquatic Plant Management Plan (APMP), the Pipe Lakes Protection and Rehabilitation District, Cedar Corp. and ERS, LLC decided that monthly transect surveys at the lakes' boat landings would be a prudent measure considering the increasing number of neighboring lakes that EWM has invaded (Horseshoe, Echo, Beaver Dam, Lower Vermillion, Duck etc.). These surveys will be conducted annually until the next full Point Intercept Survey. At that time, this and the rest of the items in the lakes' APMP will be reexamined.

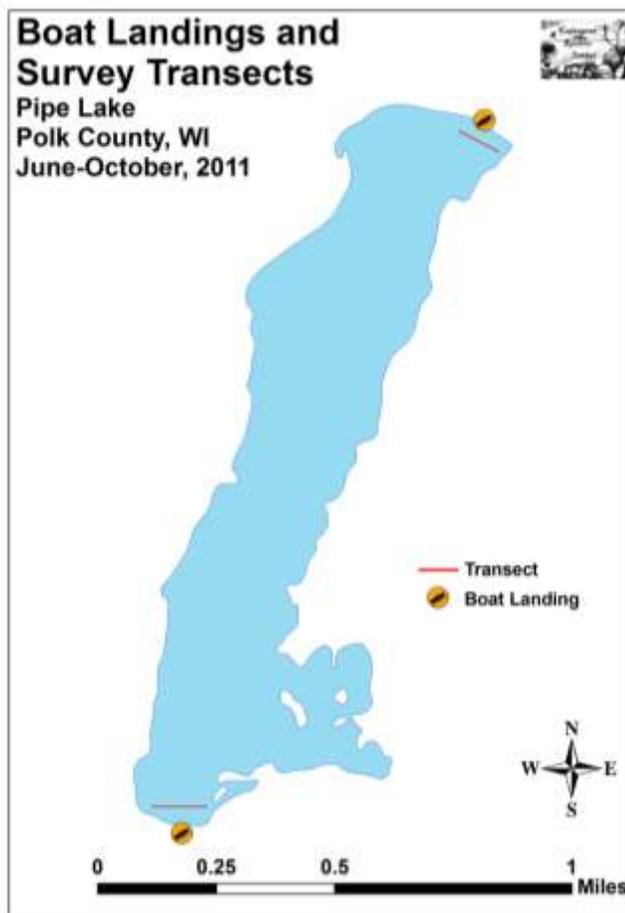
**Figure 2: Boat Landings and EWM Survey Transects 2011**

During the five months from the June-October 2011, we conducted landing inspections at least once a month at the north boat landing and the “unofficial” south landing on Pipe Lake (Figure 2). If conditions allowed (not raining and/or no people present swimming in area), we initially conducted a boat survey of the area. Using three 100-150m parallel transects approximately 15, 30 and 45m from shore; we motored at idle speed looking for any evidence of EWM’s characteristic red growth top. Once we had finished the three transects, we returned to our starting point using a stitch pattern that crossed back and forth over all three lines to look for any plants we may have missed between the transects.

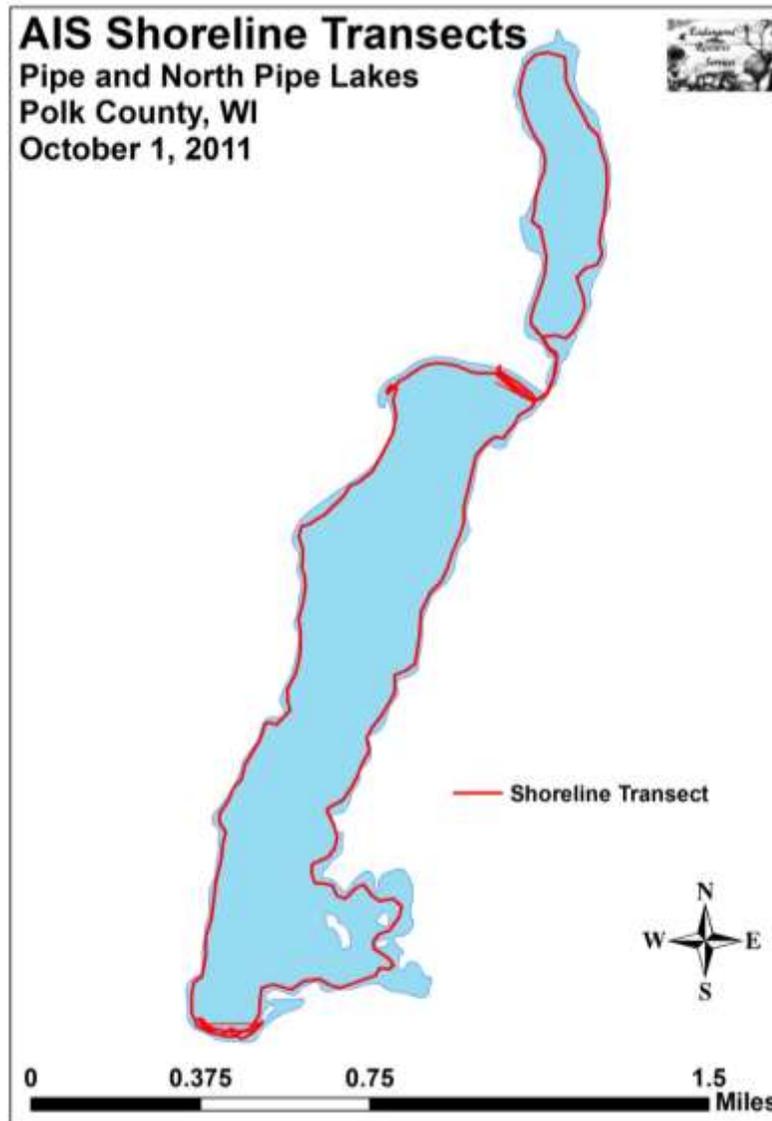
**Figure 3: October Shoreline AIS Survey 2011**

During the summer of 2011, we conducted five transect surveys on June 10<sup>th</sup>, July 9<sup>th</sup>, August 5<sup>th</sup>, September 5<sup>th</sup> and October 1<sup>st</sup>, and shoreline surveys on Pipe on June 6<sup>th</sup> and both Pipe and North Pipe on October 1<sup>st</sup> (Figure 3). Water levels, following the drought of the past few summers, had returned to normal, and the plant community was adjusting accordingly with species dying off at the edge of the littoral zone, but recolonizing areas on the shoreline edge. During the June and August surveys, I was accompanied by two other and four other divers who served as extra eyes on our search. We did not find EWM or any other aquatic invasive species in or adjacent to Pipe Lake.

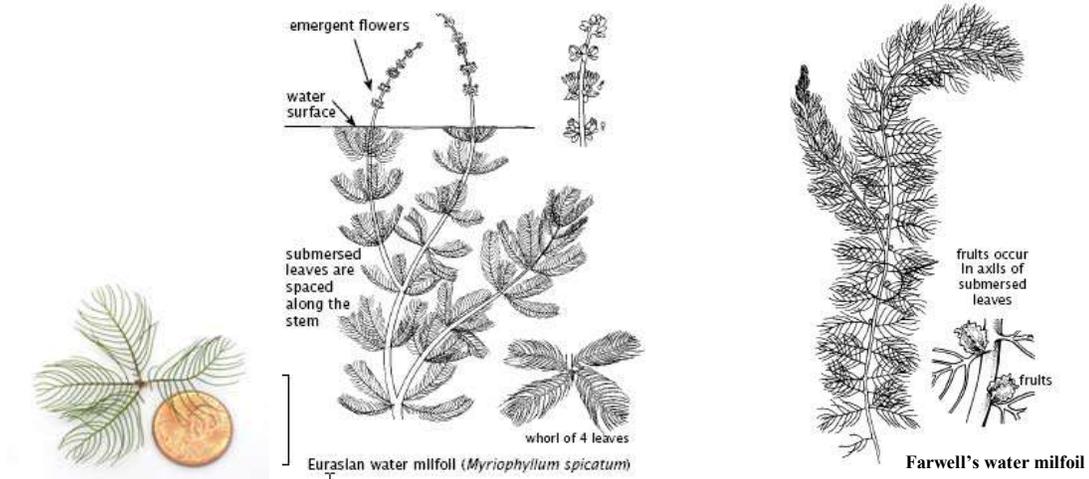
**Figure 4: EWM and Farwell's Water Milfoil Identification**  
 (Hill et al. in Maine's Field Guide to Aquatic Invasive Species and Crow and Hellquist 2006)

We again found dense beds of Farwell’s water milfoil in the sheltered bays in the southeast corner of Pipe Lake in shallow water over thick organic muck. The only plant in the Pipe Lakes that looks like EWM can be told from it by its normal number of leaflets numbering <16 whereas EWM normally has >26 leaflets (Figure 4). EWM also has an emergent flower stalk where Farwell’s flowers are scattered along the stem and look like tiny nuts.
