**August Warm-water Point-intercept Survey and  
Eurasian water milfoil (*Myriophyllum spicatum*)  
Visible Littoral Zone Survey  
North Pipe Lake (WBIC: 2485700)  
Polk County, Wisconsin**

Project Initiated by: Pipe and North Pipe Lake Protection and Rehabilitation District and the Wisconsin Department of Natural Resources

Surveys Conducted by and Report Prepared by:  
Endangered Resource Services, LLC  
Matthew S. Berg, Research Biologist  
St. Croix Falls, Wisconsin  
August 10 and October 11, 2013

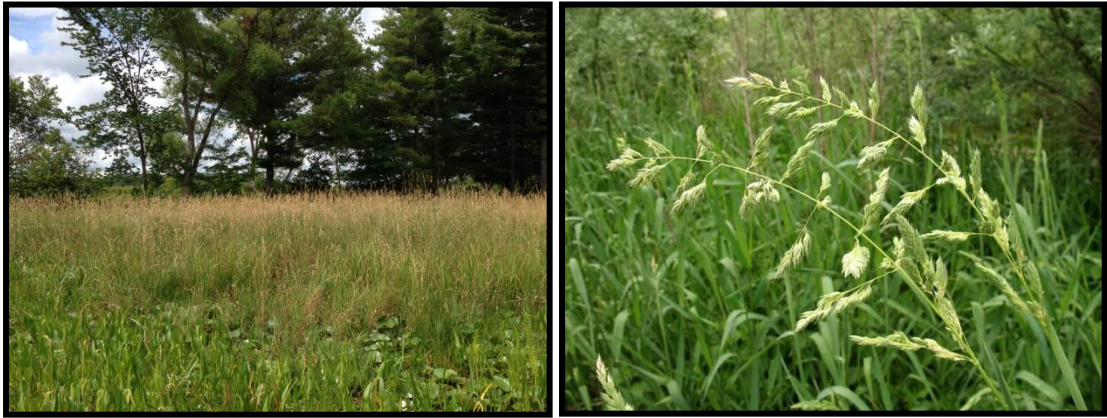
**Figure 13: Reed Canary Grass in the Channel Between the Lakes**

Reed canary grass was the only exotic species found (Figure 13). It was often a dominant plant at and just beyond the lakeshore where it has colonized extensive patches in the wetlands adjacent to the north/west bays, next to mowed and otherwise disturbed shorelines, and around the channel to Pipe Lake (Figure 14). A ubiquitous plant in the state, there's likely little that can be done about it other than minimizing its ability to spread by maintaining native shoreline vegetation.
