**August Warm-water Point-intercept Survey and
Eurasian water milfoil (*Myriophyllum spicatum*)
SCUBA and Visible Littoral Zone Surveys
Pipe Lake (WBIC: 2490500)
Polk County, Wisconsin**

Project Initiated by: Pipe and North Pipe Lake Protection and Rehabilitation District and the Wisconsin Department of Natural Resources

Surveys Conducted by and Report Prepared by:
Endangered Resource Services, LLC
Matthew S. Berg, Research Biologist
St. Croix Falls, Wisconsin
July 1, August 10-11, September 22, and October 11, 2013

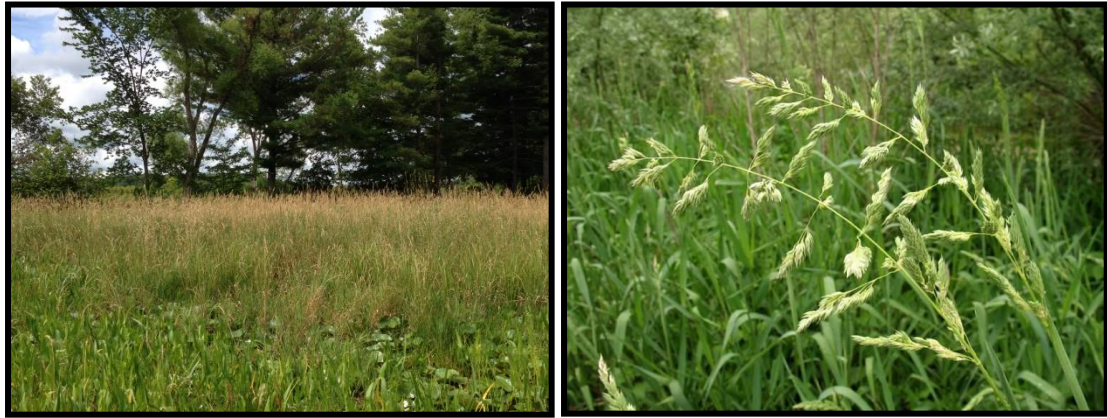
Figure 14: Reed Canary Grass in the Channel Between the Lakes

Reed canary grass was the only exotic species found. It was often a dominant plant just beyond the lakeshore, and, similar to 2007, we noticed extensive patches in the wetlands adjacent to the south bays, next to mowed and otherwise disturbed shorelines, and around the channel to North Pipe Lake (Figure 14). A ubiquitous plant in the state, there's likely little that can be done about it other than minimizing its ability to spread by maintaining native shoreline vegetation.
