**Summary of Monitoring at Boat Landings for
Eurasian Water Milfoil (*Myriophyllum spicatum*) on
Pipe Lake (WBIC: 2490500) and North Pipe Lake (WBIC: 2485700)
Polk County, Wisconsin**

Project Initiated by:
Pipe Lakes Protection and Rehabilitation District

Landing Monitoring and Shoreline Surveys
Conducted by and Report Prepared by:
Endangered Resource Services, LLC
Matthew S. Berg, Research Biologist
St. Croix Falls, Wisconsin
June-October, 2016

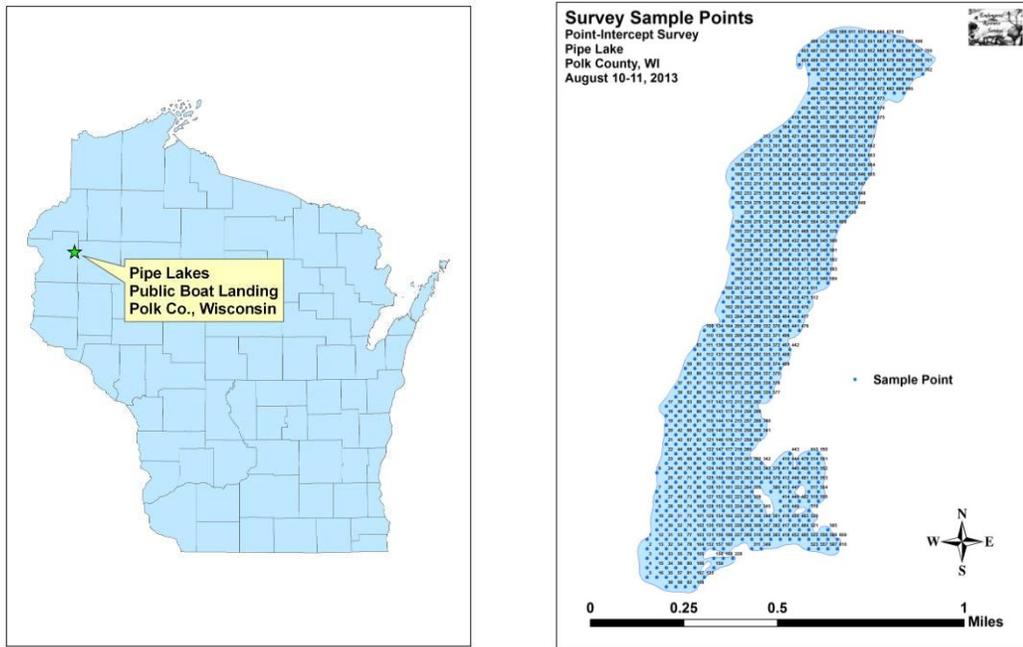
Figure 1: Pipe Lakes, Polk Co., WI and Point Intercept Points 2013

During the summers of 2007 and 2013, extensive point-intercept plant surveys found there was no Eurasian water milfoil (*Myriophyllum spicatum*) in the Pipe Lakes (Figure 1). As part of their Aquatic Plant Management Plan (APMP), the Pipe Lakes Protection and Rehabilitation District decided that monthly transect surveys at the lakes' landings would be a prudent measure considering the increasing number of neighboring lakes that have EWM infestations (Horseshoe, Echo, Beaver Dam, Kidney, Shallow, Lower Vermillion, and Duck).

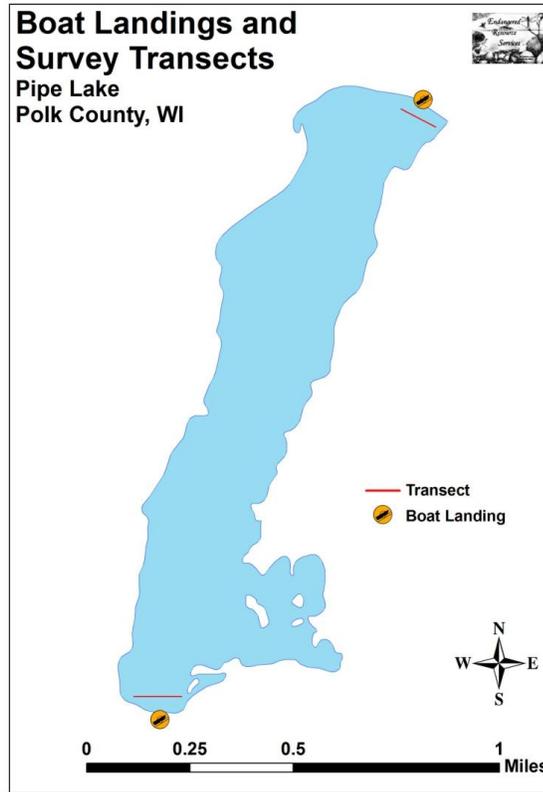
Figure 2: Boat Landings and EWM Survey Transects 2016

During the five month growing season from June-October 2016, we conducted landing inspections at least once a month at the north boat landing and the “unofficial” south landing on Pipe Lake (Figure 2). If conditions allowed us to see deep into the littoral zone (not raining/good water clarity/no people present swimming at the north beach), we conducted a boat survey to look for EWM. Using three 100-150m parallel transects approximately 15, 30 and 45m from shore; we motored at idle speed looking for any evidence of EWM’s characteristic red growth top. Once we had finished the three transects, we returned to our starting point using a stitch pattern that crossed back and forth over all three lines to look for any plants we may have missed between the transects. As EWM primarily reproduces by shedding numerous vegetative fragments, we also walked along the north landing shoreline to look for pieces of EWM that would likely wash up if plants were present.

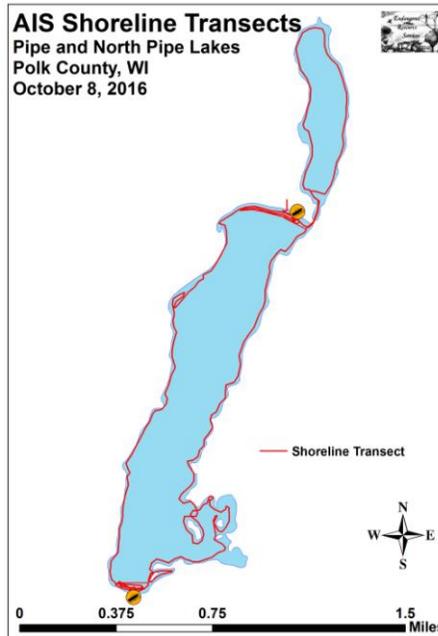
Figure 3: October 8, 2016 Full Shoreline AIS Survey

In late May 2015, Dick Hollar and Greg Warner – PLPRD - informed us that a boat trailer that had a considerable amount of Curly-leaf pondweed (*Potamogeton crispus*) on it had launched at the north landing. As in 2015, despite extensive looking during our initial June 14th survey, we found **NO** evidence of CLP in the lakes. In addition to this preliminary search, we also conducted four transect surveys on July 15th, August 15th, September 18th (a training dive where we were joined by 6 other volunteers), and October 10th. We also conducted whole-lake aquatic invasive species (AIS) shoreline surveys on both Pipe and North Pipe on June 14th and October 8th (Figure 3). Fortunately, we did **NOT** find any evidence of CLP, EWM or any other AIS in or adjacent to the lakes other than the previously reported Reed canary grass (*Phalaris arundinacea*), and even this seemed to have diminished with the rising lake levels experienced during the 2016 growing season.

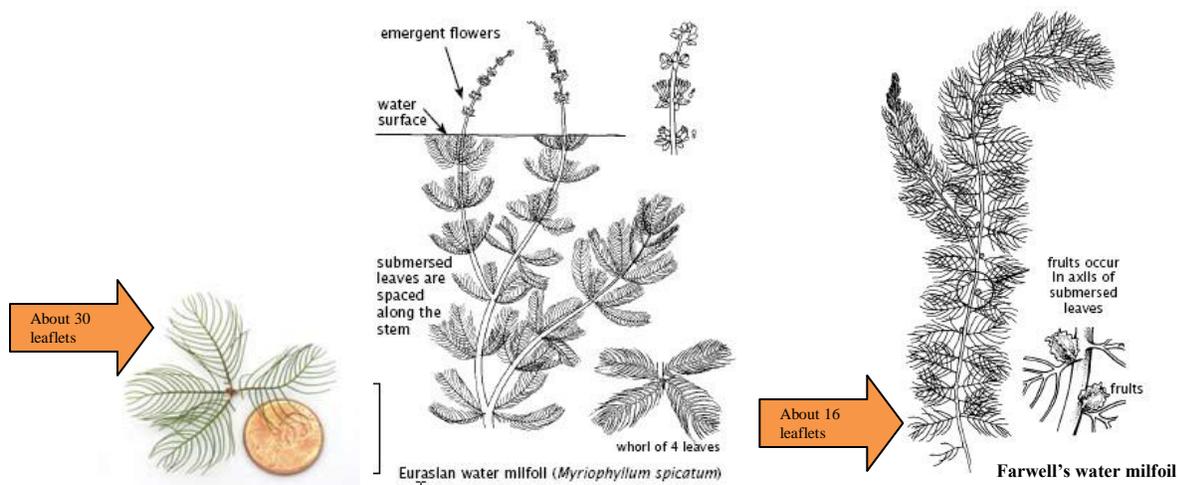
Figure 4: EWM and Farwell’s Water Milfoil Identification
(Hill et al. in Maine’s Field Guide to Aquatic Invasive Species and Crow and Hellquist 2006)

As in the past, the only branched/feathery aquatic plant we found in the lakes was Farwell’s water milfoil (*Myriophyllum farwellii*) – a valuable habitat producing native plant that is relatively uncommon in the state. It continues to grow in dense beds in the sheltered bays of the southeast corner of Pipe Lake in shallow water over thick organic muck (especially near the beaver lodge on the east side of the northeast island). Farwell’s is also found scattered through North Pipe Lake, but here it is very uncommon and never bed forming. Farwell’s water milfoil can be told from Eurasian water milfoil in that it has leaves with leaflets numbering <16 whereas EWM normally has >26 leaflets (Figure 4). EWM also has an emergent flower stalk where Farwell’s flowers are scattered along the stem and look like tiny nuts.
