Lake Management Plan for the Pipe Lakes, Polk County, Wisconsin

July 2004

Prepared by Steve McComas, Blue Water Science
with contributions from Wisconsin Department of Natural Resources
and the Pipe Lakes Protection and Rehabilitation District

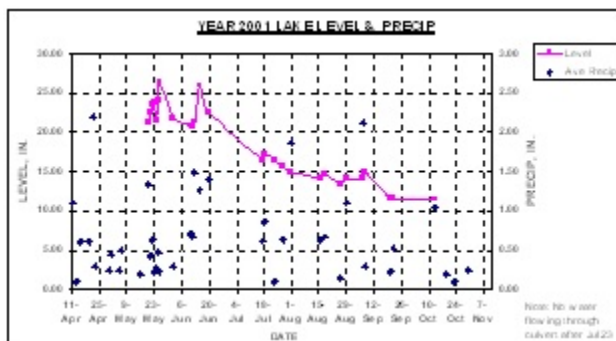
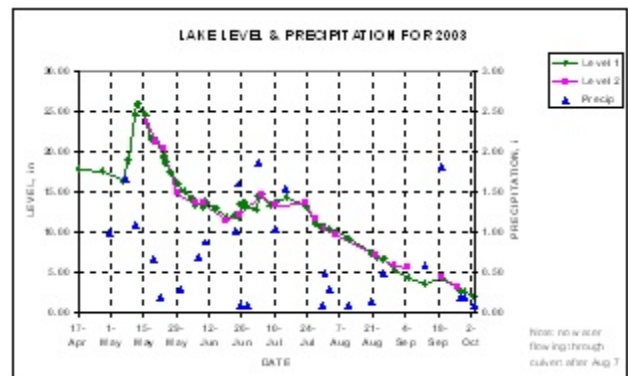
Figure 6. Lake levels and precipitation for the Pipe Lakes.

Rainfall: Rainfall is a significant source of water to the Pipe Lakes. Rainfall measurements and lake levels have been taken over the last few years by Pipe Lake volunteers and results are shown in Figure 6. Although lake levels fall over the course of the summer, due primarily to evaporation and infiltration, rainfall does influence lake levels, in the form of direct impacts as well as watershed runoff.

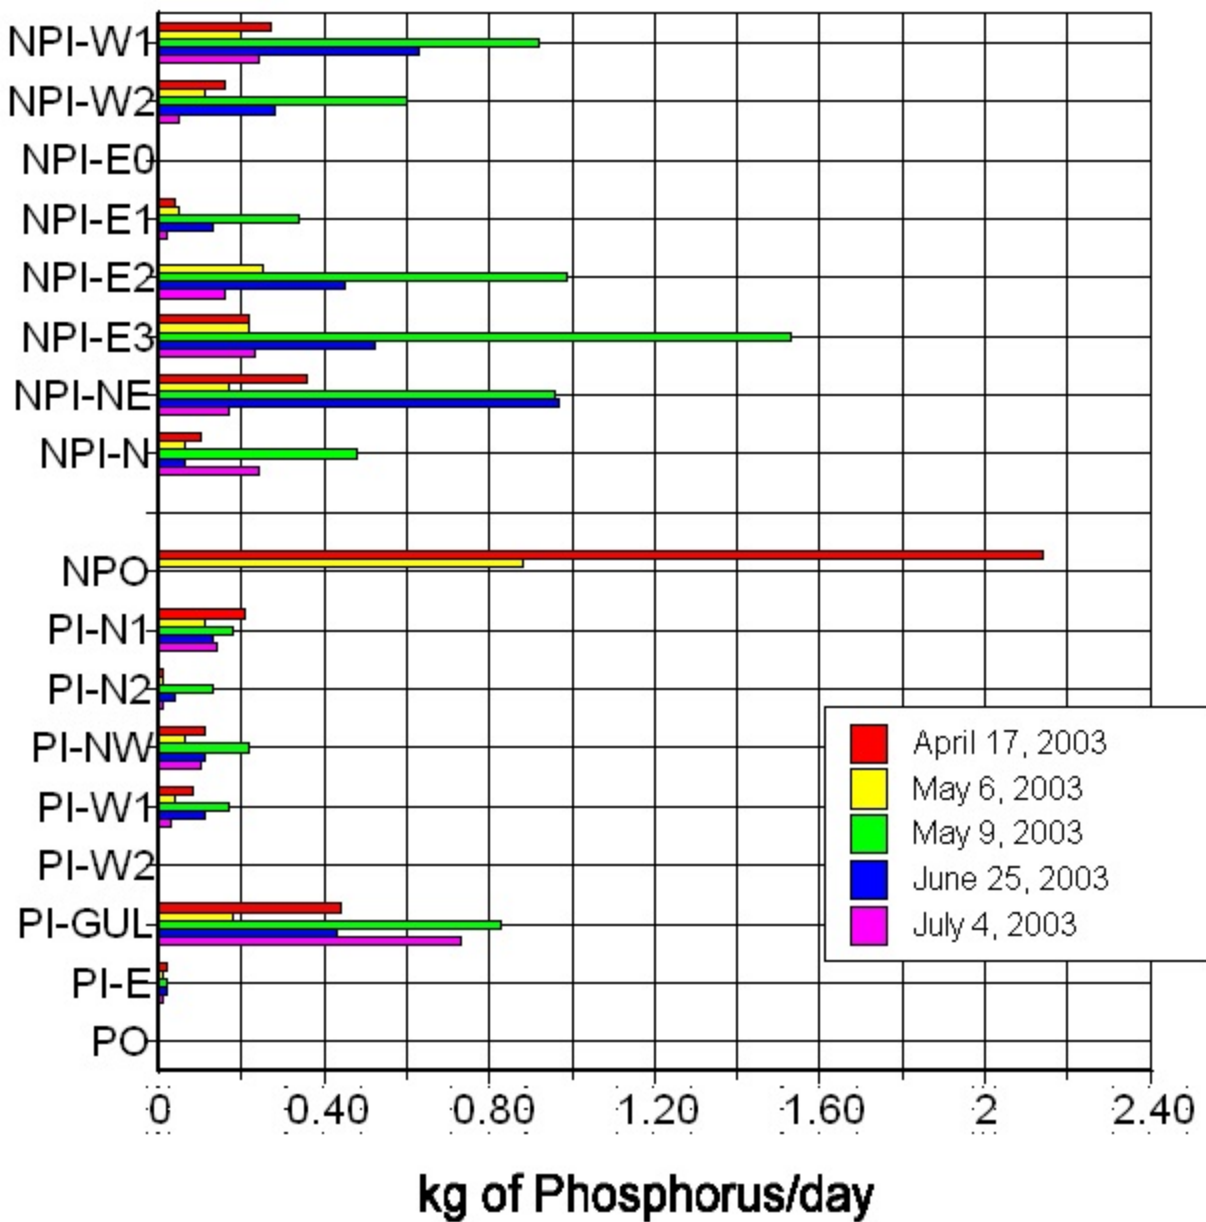
Figure 8. Daily stream loads.

A summary of estimated daily phosphorus loads from stream sampling results are shown in Figure 8. Sample sites NPI-E3 and NPI-NE had some of the highest loads in the North Pipe watershed and NPO and PI-GUL had the highest loads into Pipe Lake. NPO is the flow from North Pipe into Pipe Lake.

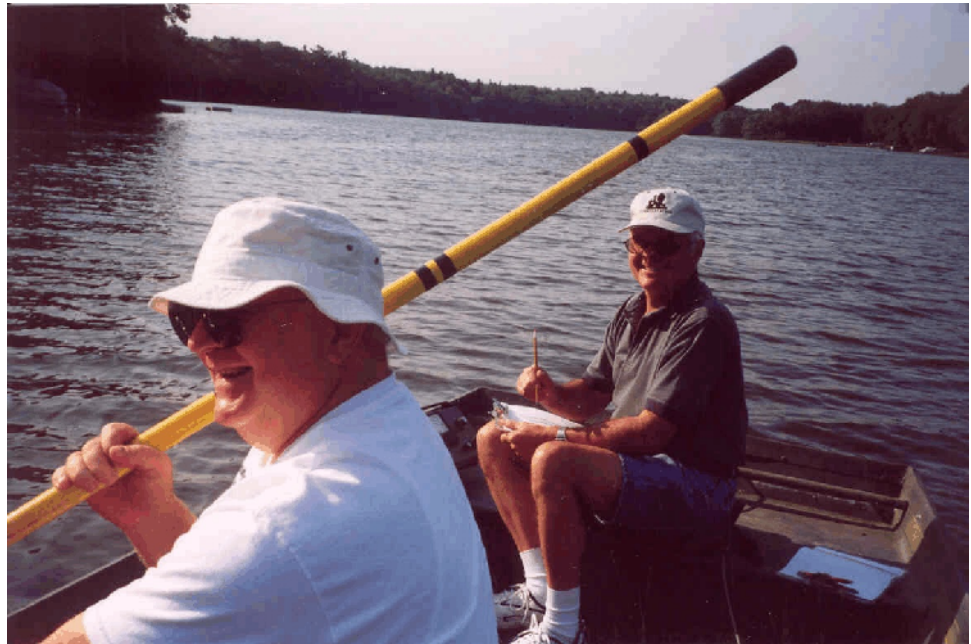
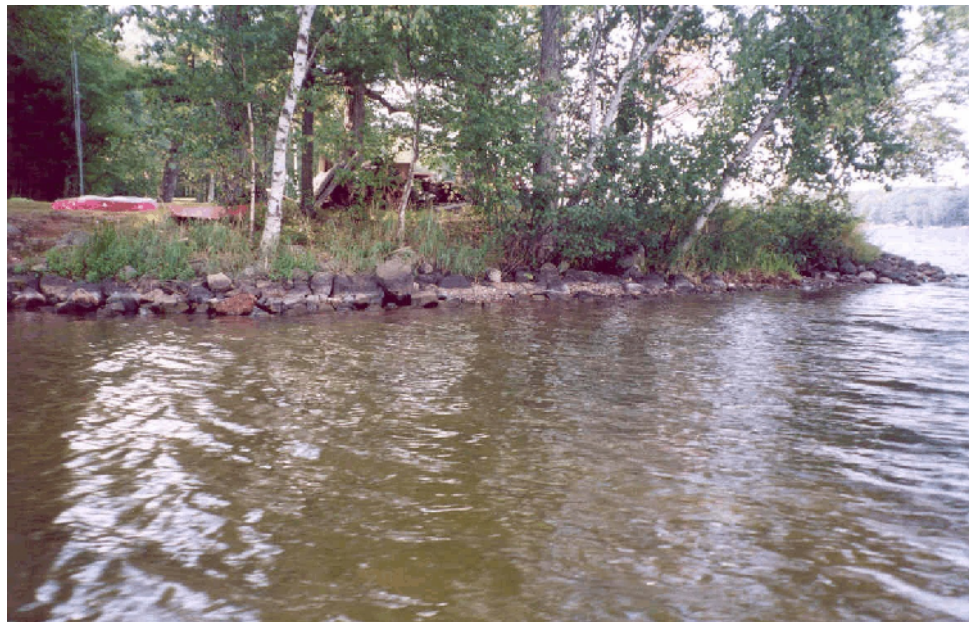
Figure 9. [top] Pipe Lake volunteers assisted with the shoreline conductivity survey. [bottom] A rocky point like this on Pipe Lake sometimes serves as a conduit for groundwater inflows. However, groundwater inflow was not detected here. In fact, it appears that groundwater inflow is minor in the Pipe Lakes.

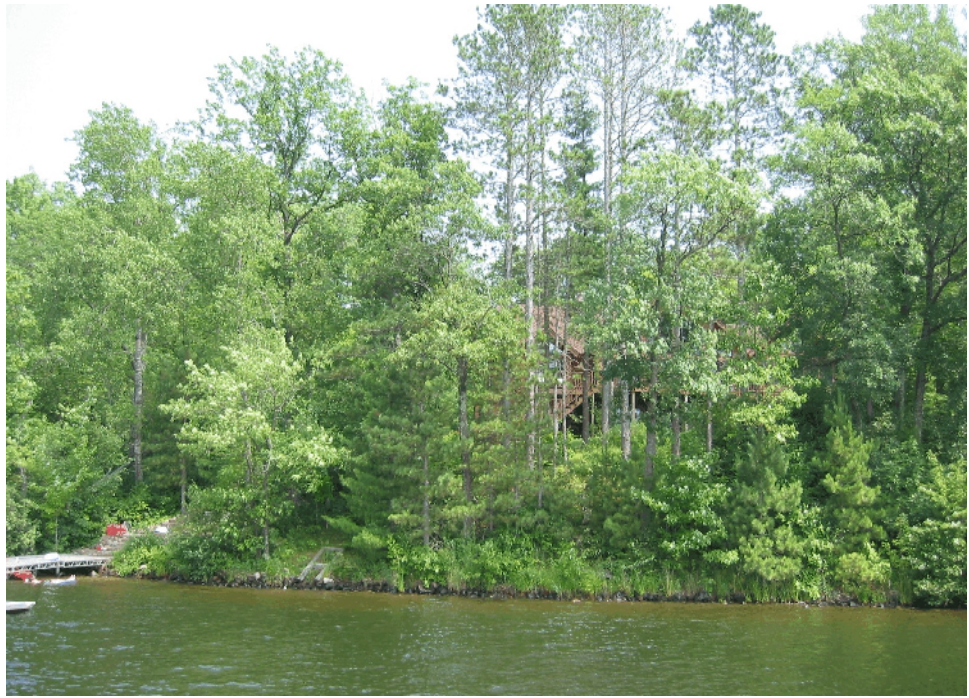
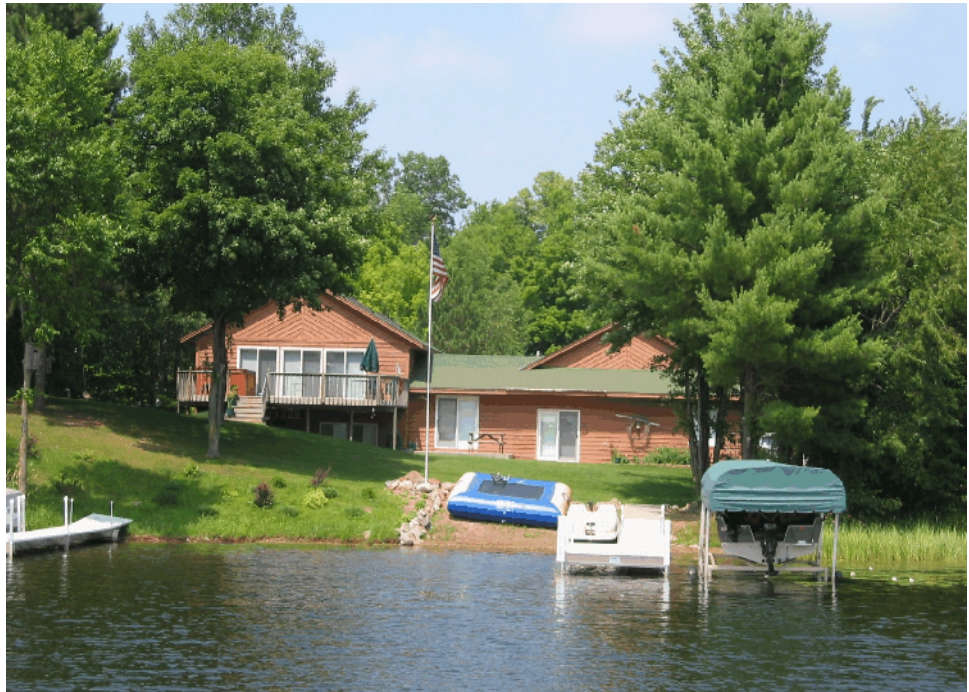
Figure 12. Both of the pictures are from Pipe Lake. [top] This parcel would rate as having a shoreline with a buffer greater than 50% of the lot width and an understory (ground cover) with greater than 50% natural cover. [bottom] This parcel would not qualify as having a natural shoreline buffer greater than 50% of the lot width. Also the understory in the upland area is dominated by lawn cover and would be rated as having less than 50% natural cover.

For each photograph we looked at the shoreline and the upland condition. Our criteria for natural conditions were the presence of 50% native vegetation in the understory (ground cover) and at least 50% natural vegetation along the shoreline in a strip at least 15 feet deep. Although the county shoreline ordinance for new development is a 35-foot deep buffer, a 15-foot deep buffer is the minimum needed to achieve some degree of runoff water quality treatment. We evaluated shorelines and uplands at the 75% natural level as well (Figure 12 illustrates the methodology).

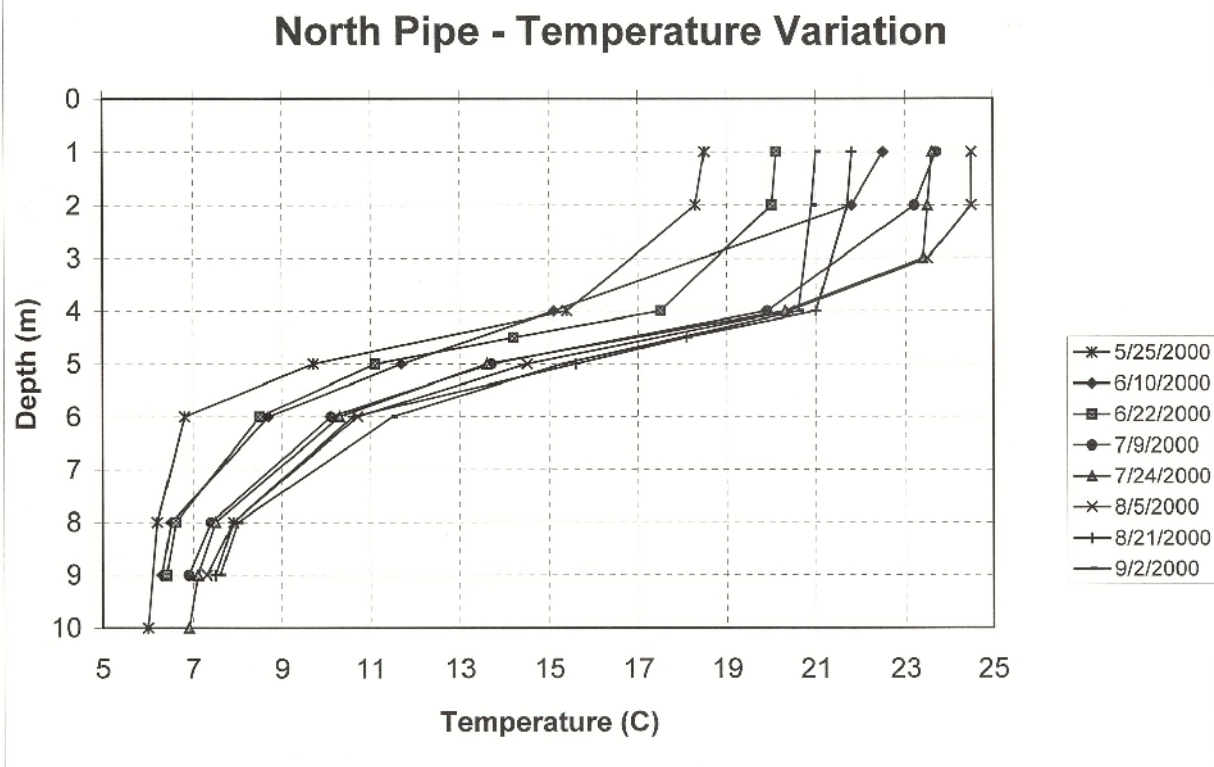
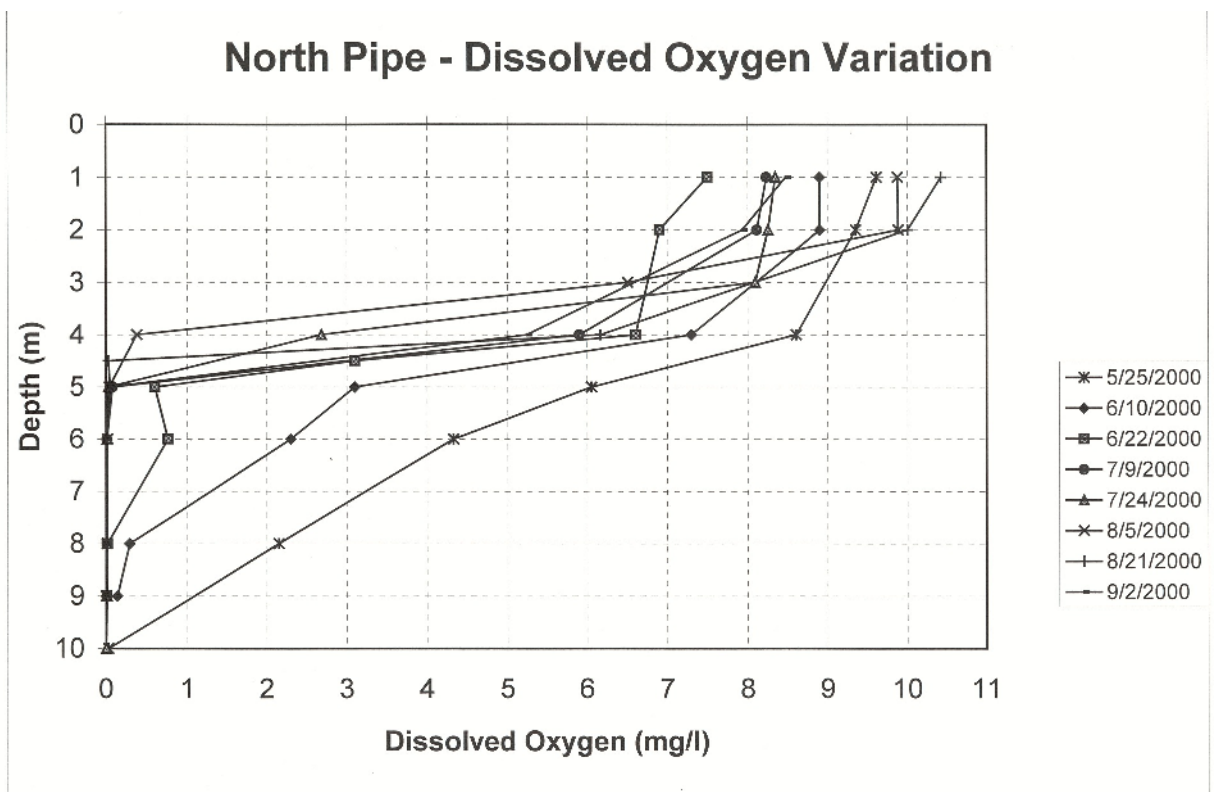
Figure 17. Dissolved oxygen (DO)/temperature profiles for North Pipe Lake for 2000. Dissolved oxygen data are shown in the bottom graph and temperature data are shown in the top graph.

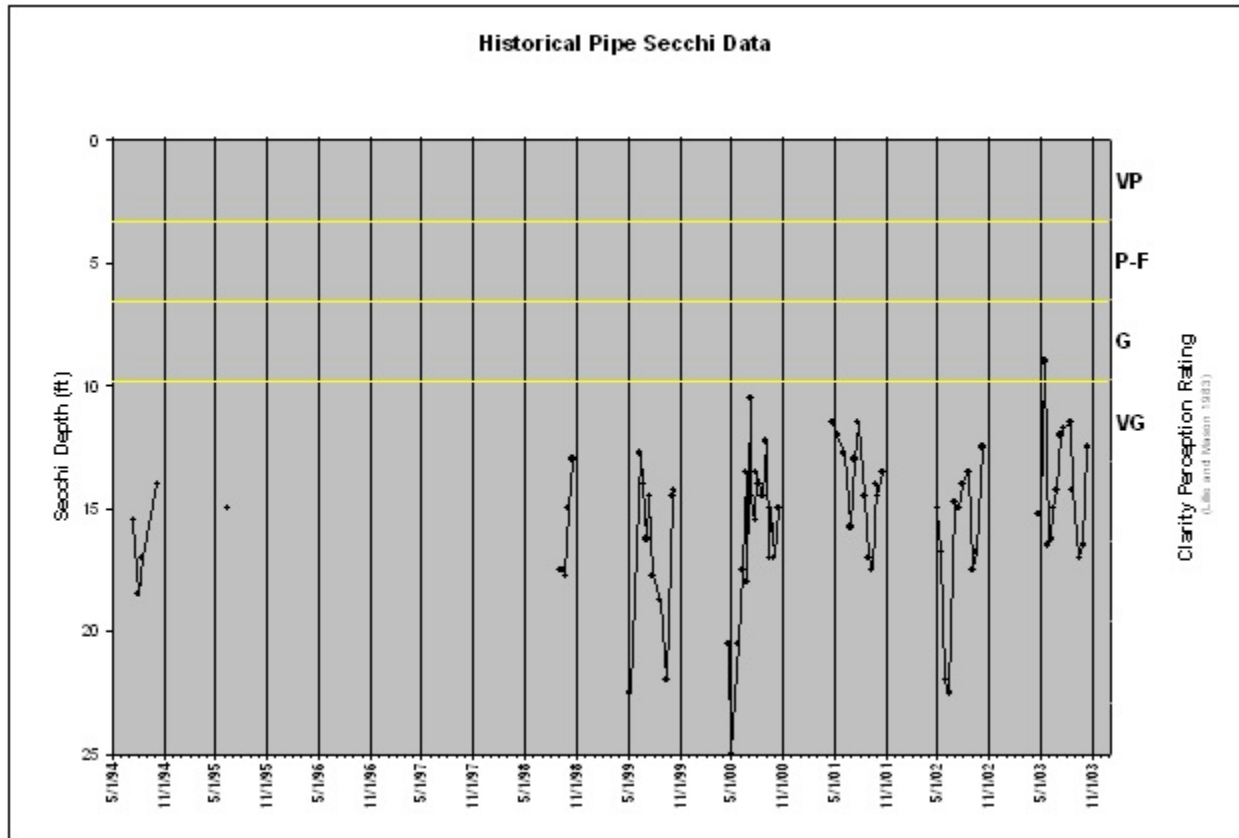
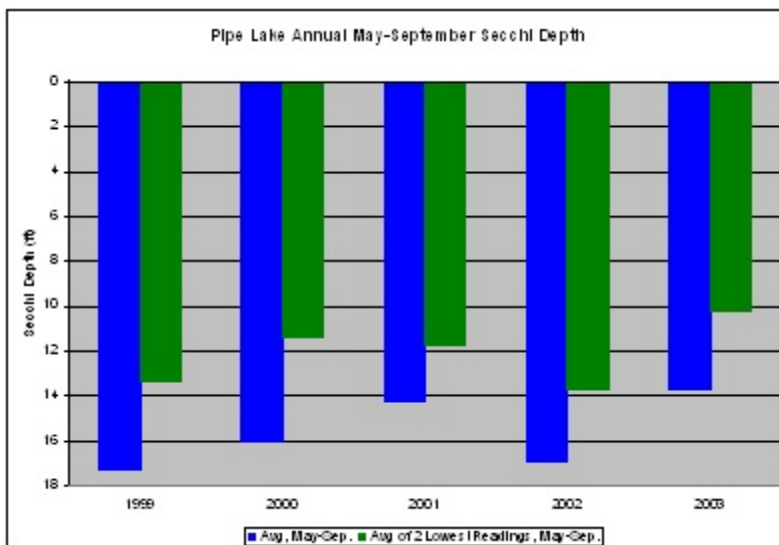
Figure 20. Secchi disc results for Pipe Lake.

Water clarity is commonly measured with a Secchi disc. Secchi disc results for North Pipe Lake are shown in Figure 19 and for Pipe Lake in Figure 20. Both North Pipe and Pipe show typical seasonal fluctuations with Pipe Lake having the better overall clarity.

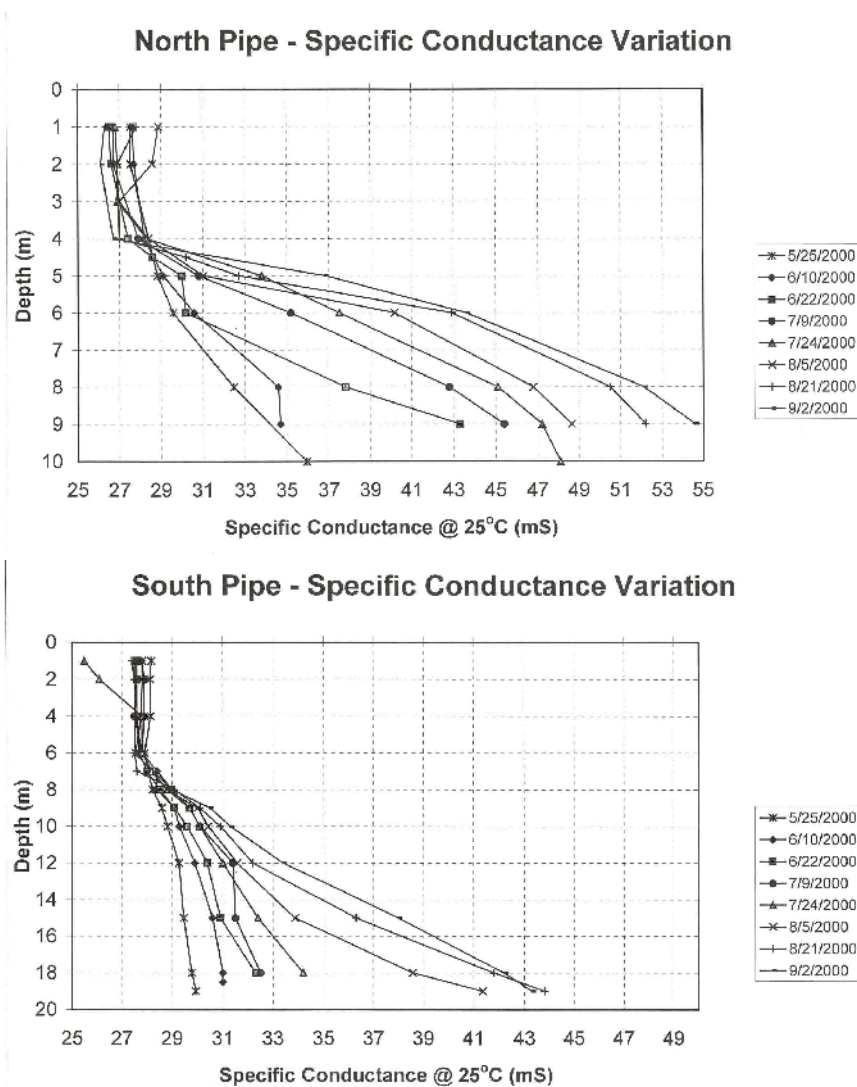
Figure 21. Specific conductance measured for North Pipe and Pipe Lakes in 2000.

In addition to Secchi disc, total phosphorus, and chlorophyll *a*, several other water quality parameters were collected in 2000. Specific conductance is low in North Pipe and Pipe (Figure 21). It increased in the bottom water which is typical. Additional data are listed in Tables 14 and 15. Two observations stand out. Alkalinity is fairly low for both lakes and this indicates there is not much acid buffering potential. Low alkalinity would make the use of alum more complicated if it is considered in the future. Also, the color of the lake water is different between North Pipe and Pipe. North Pipe has a higher color reading than Pipe Lake. The brownish-reddish color probably originates from wetland discharges to streams which flow into North Pipe. This may also slightly lower the transparency readings in North Pipe.

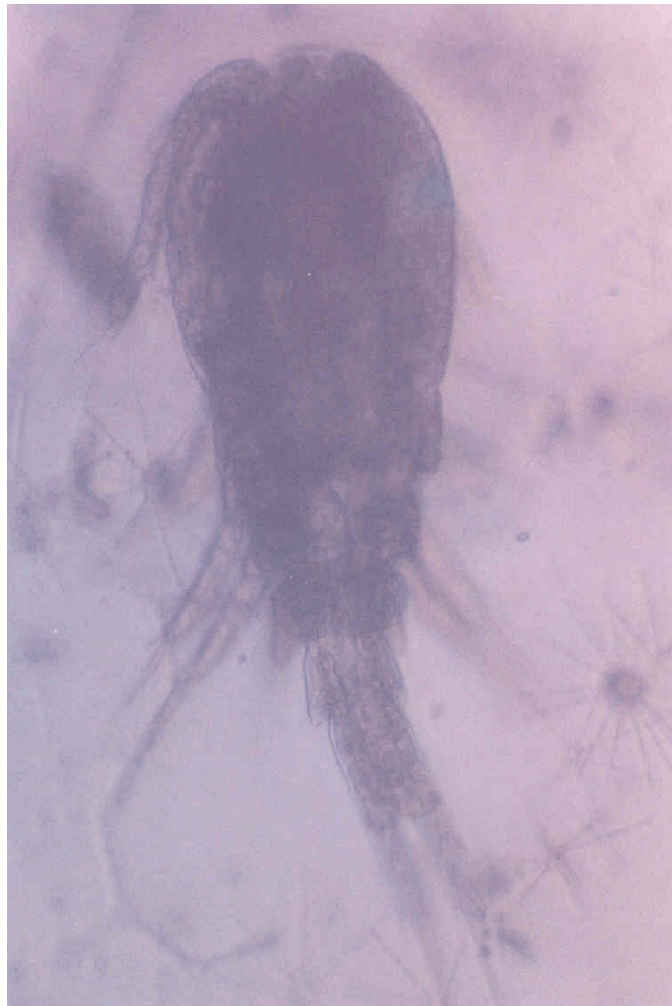
Figure 22. Example of zooplankton species from North Pipe Lake on May 7, 2003.

Zooplankton are small crustaceans that can feed on algae. An example of a zooplankter from Pipe Lakes is shown in Figure 22. The zooplankton community has typical zooplankton species for lakes in Northern Wisconsin although there was limited sampling in 2003. In the photo below, the image of a copepod is magnified 150 times.

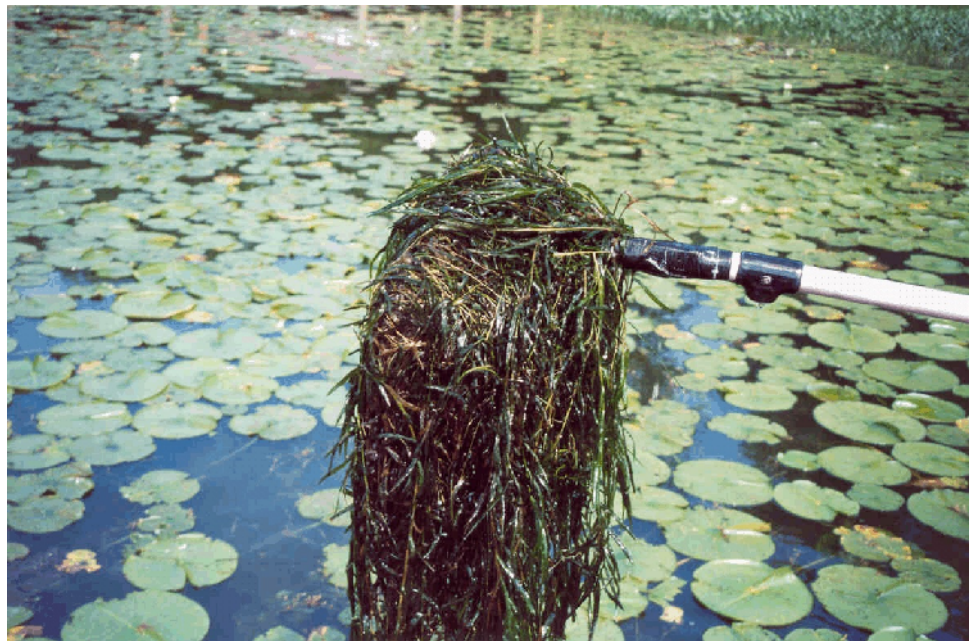
Fern pondweed was found at four stations in North Pipe Lake.

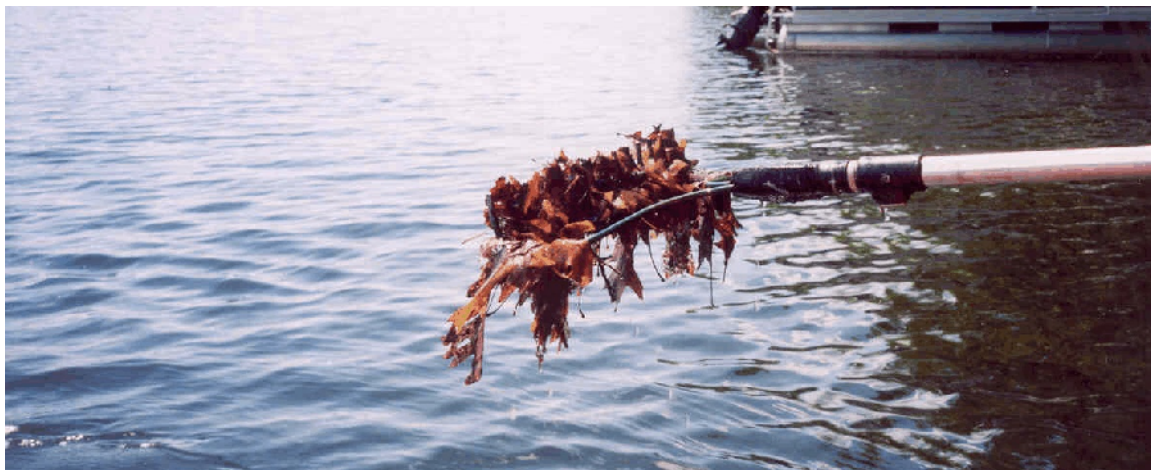
Aquatic plants are sparse along most of the shoreline in Pipe Lake.

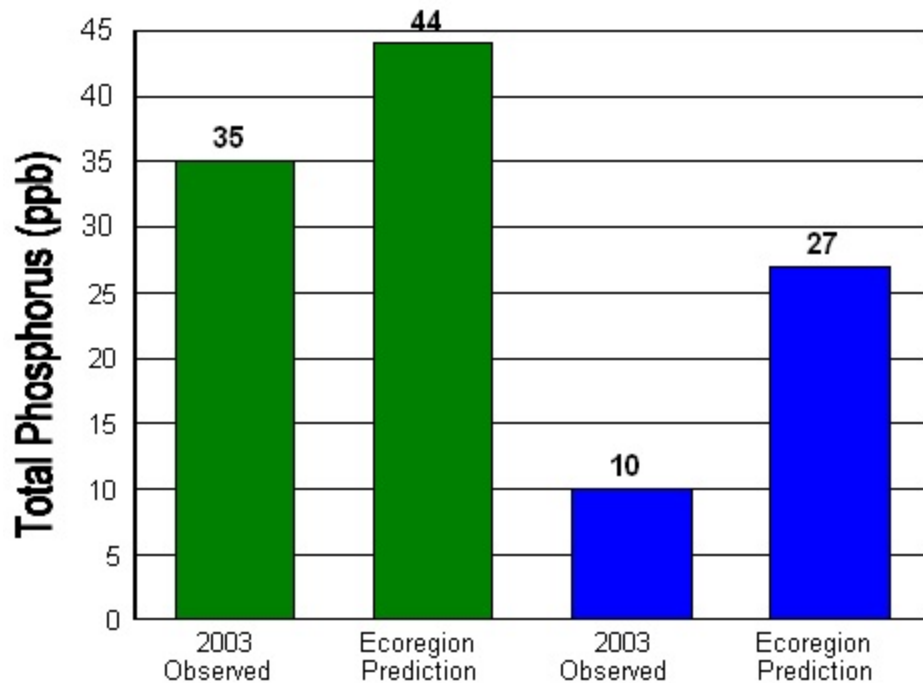
Figure 24. Comparison of total phosphorus conditions for the Pipe Lakes in 2003 to predicted conditions for a lake and watershed with the size of North Pipe and Pipe Lakes situated in the North Central Hardwood Forest ecoregion. Green bars are North Pipe and blue bars are Pipe Lake.

Ecoregion lake models for North Pipe and Pipe Lakes were run using North Central Hardwood Forest Ecoregion inputs and the results were compared to observed lake conditions for 2003. Results are shown in Figures 24 and 25. Water quality in the Pipe Lakes is good to excellent.

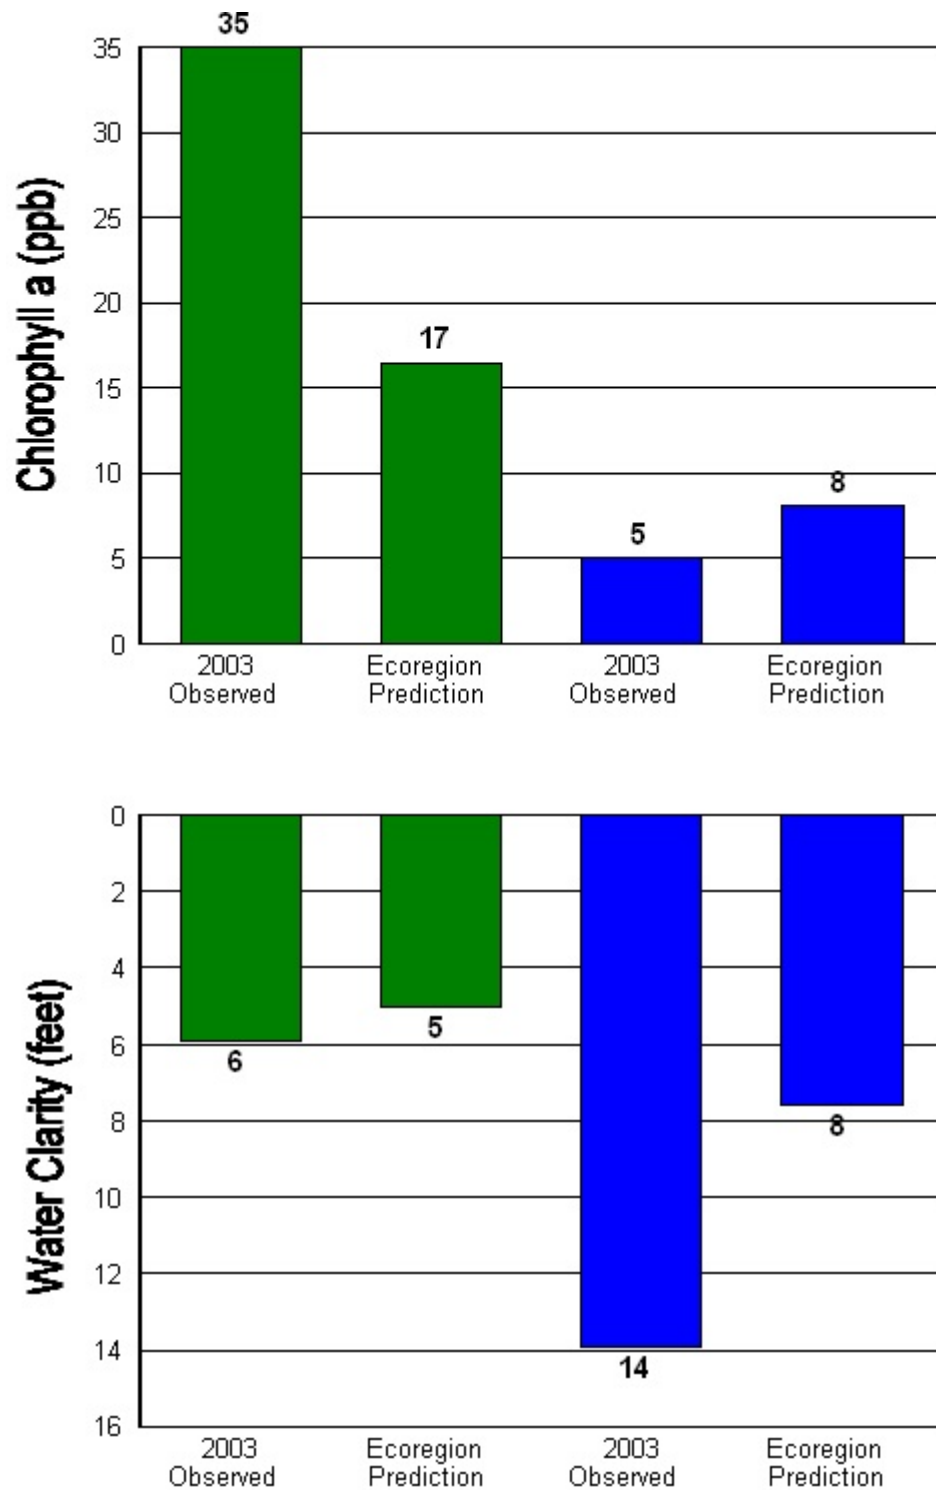
Figure 25. Comparison of chlorophyll *a* and water clarity conditions for the Pipe Lakes in 2003 to predicted conditions for a lake and watershed with the size of North Pipe and Pipe Lakes situated in the North Central Hardwood Forest ecoregion. Green bars are North Pipe Lake and blue bars are Pipe Lake.

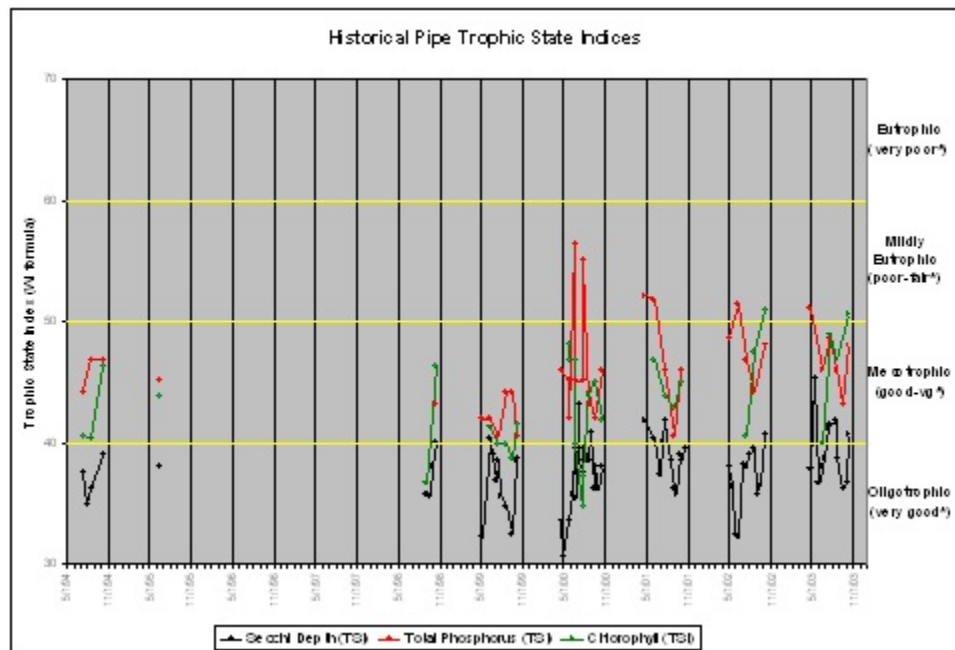
Figure 26. The Trophic State Index (TSI) converts values collected for Secchi disc transparency, total phosphorus, and chlorophyll into a scale from roughly 1 to 100, with 1 being the best water quality. All three water quality parameters are related and a TSI value is often the same for all three parameters. For North Pipe (top graph) the Secchi disc TSI is lower than chlorophyll and phosphorus. For Pipe Lake the Secchi TSI is also better (meaning there is a lower TSI value) than the TSI for chlorophyll and phosphorus. In these cases, water clarity is better than would be expected based on TSI conversions.

The trophic state index chart for North Pipe Lake (Figure 26) has chlorophyll and phosphorus values hovering closer to the Secchi values than for Pipe Lake. The phosphorus levels in North Pipe Lake were much higher in the spring of 2003 than previously measured. This high spring level may have contributed to the more severe reduction in clarity during the summer than has been previously measured. The TSI values range from mesotrophic to eutrophic. Mildly eutrophic is between 6.6 and 3.3 feet Secchi depth. Eutrophic is less than 3.3 feet Secchi depth.

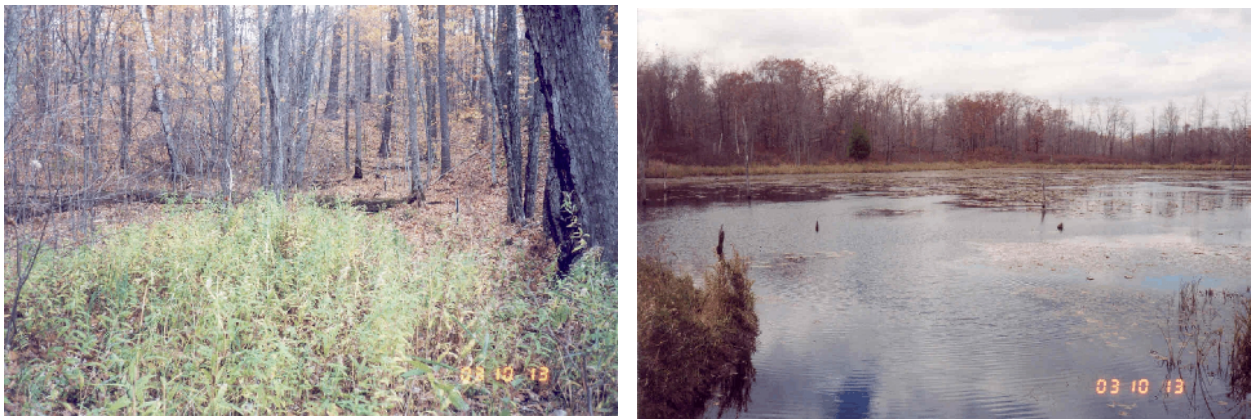
**Figure 28. [left] Forest setting in North Pipe watershed in subwatershed NP1-E2.
[right] Wetland in North Pipe watershed in subwatershed NP1-N.**

Basic Program: Maintain a photolog of typical forest and wetland areas to serve as a benchmark for future reference. Sample open water wetlands for total phosphorus once or twice a summer. Conduct sampling every couple of years.

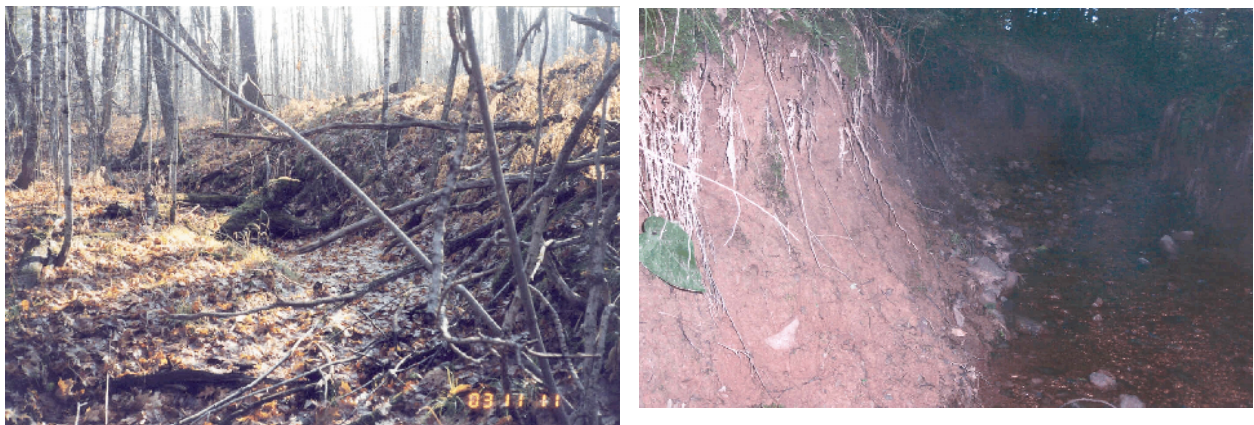
**Figure 29. [left] Streambank section in subwatershed NP1-E3.
[right] Streambank section in subwatershed NP1-W2.**

Advanced Program: Based on the stream inventory conducted by lake resident volunteers, there are stretches where tributary streambanks are eroding. The Lake District should contract with the County Resources Department or a consulting engineer to use biostabilization techniques to stabilize eroding streambanks.

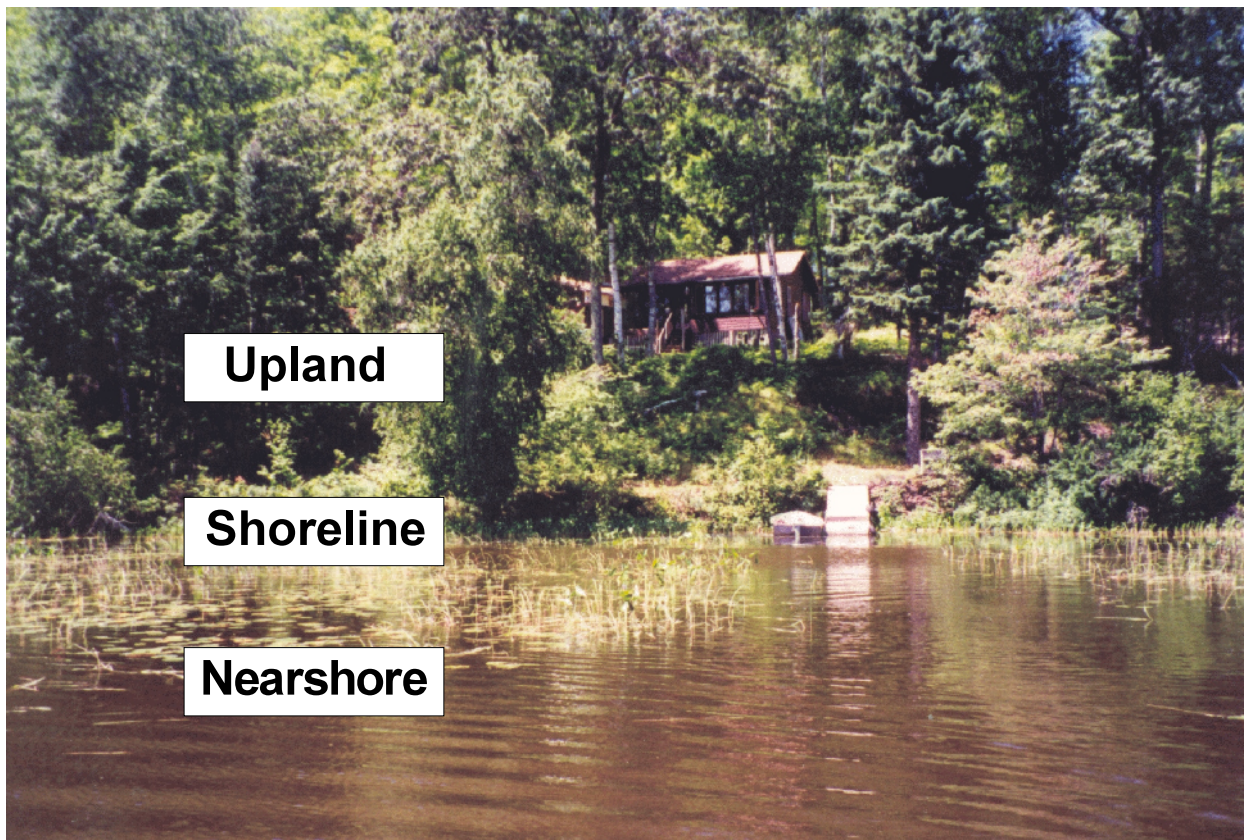
Figure 30. Cross section of the lake shoreland habitat.

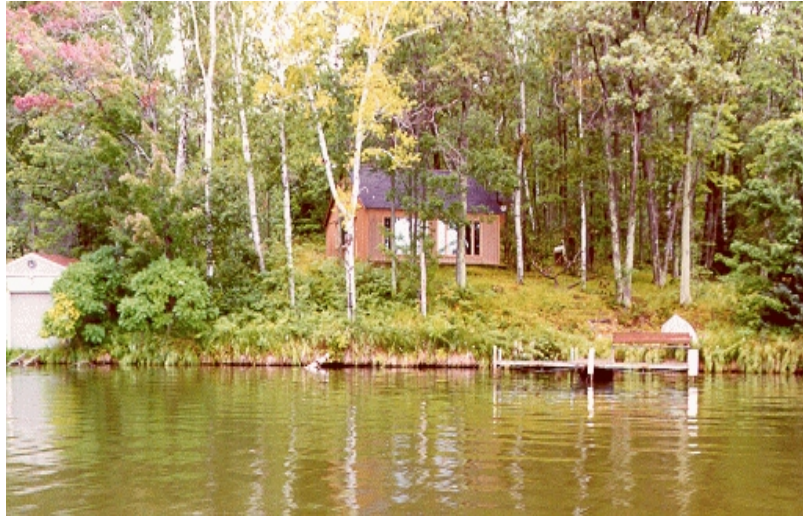
1. Naturalization: The easiest way to implement a natural shoreline setting is to select an area and leave it grow back naturally.

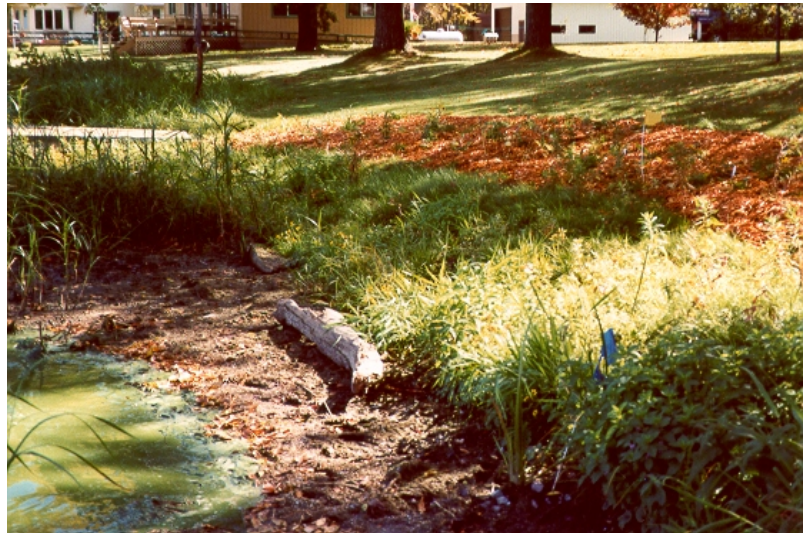
2. Accelerated Naturalization: To accelerate the naturalization, plant shrubs, wild flowers, or grasses into a shoreland area.

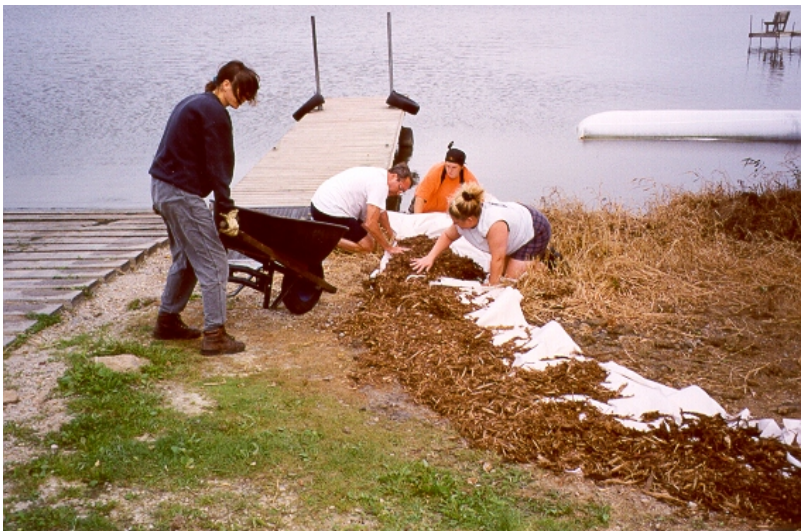
3. Restoration: This involves removing existing vegetation through the use of paper mats and/or mulching and planting a variety of native grasses, flowers, and shrubs into the shoreland area.

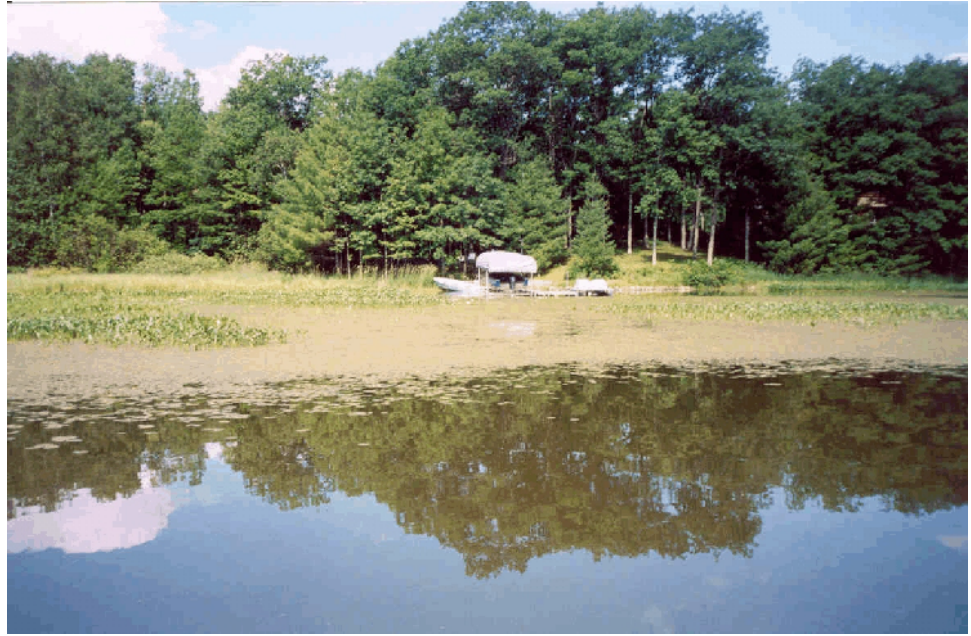
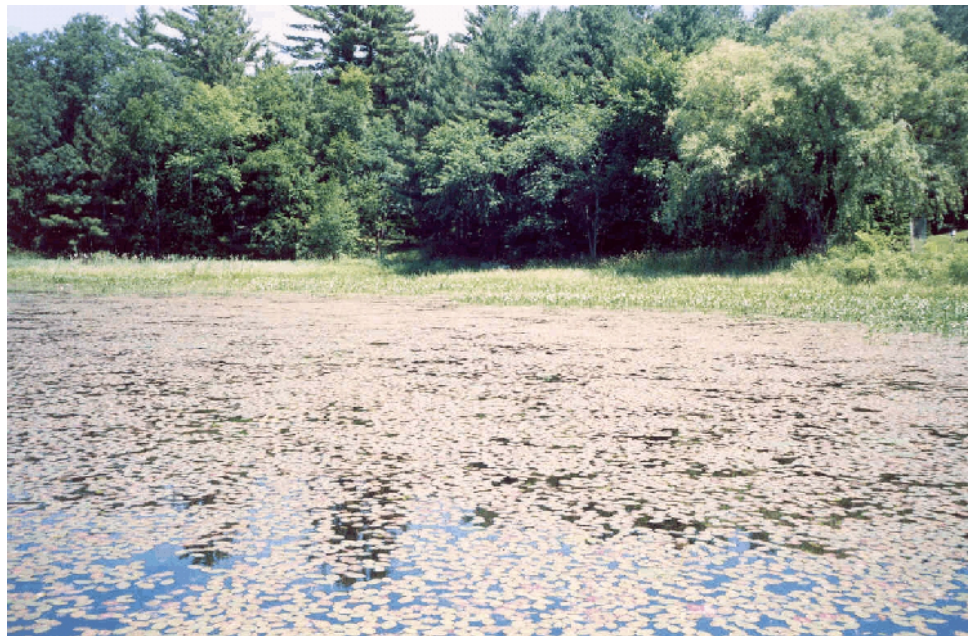
Shallow coves and bays in North Pipe (shown above) and in Pipe (bottom photo) have the best aquatic plant growth. Otherwise plant growth is sparse along the sandy rocky shorelines of the Pipe Lakes.

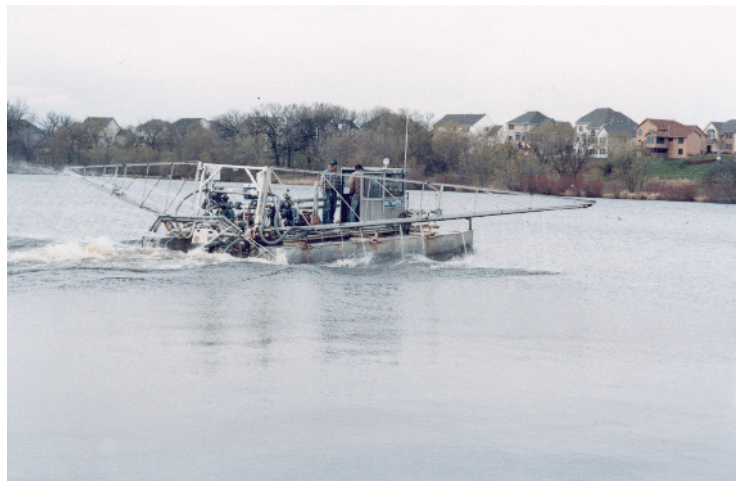
(right) An alum addition would probably reduce internal loading in North Pipe, but it is expensive.
