**Eurasian Water-milfoil (*Myriophyllum spicatum*)
Boat Landing and Meandering Littoral Zone Surveys
Pipe/North Pipe Lakes - WBIC: 2490500 and 2485700
Polk County, Wisconsin**

**Landing Monitoring and Shoreline Surveys
Conducted by and Report Prepared by:**

Endangered Resource Services, LLC
Matthew S. Berg, Research Biologist
St. Croix Falls, Wisconsin
June-October, 2024

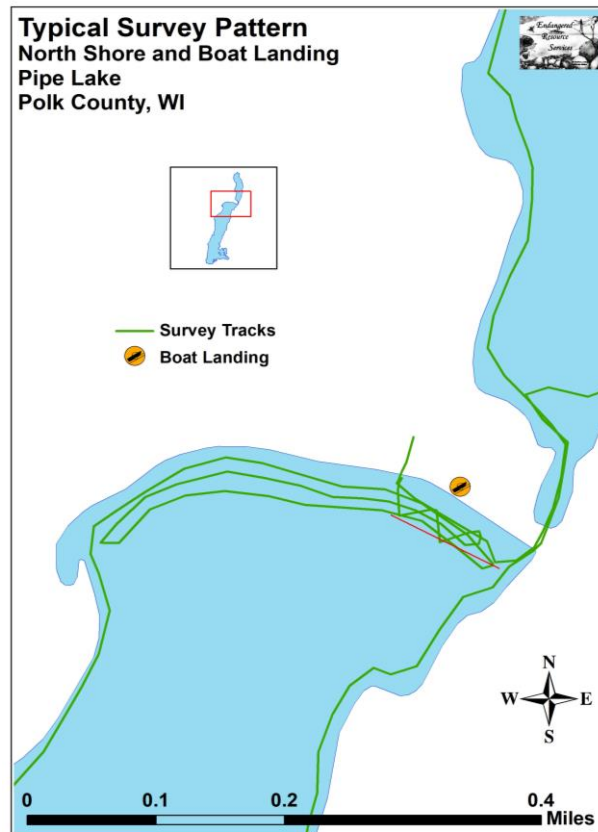
Figure 2: Boat Landing and Typical Survey Transects

During the growing season from June to October 2024, we conducted landing inspections approximately once a month along the north shoreline near the public boat landing (Figure 2). Using three 100-150m parallel transects approximately 15, 30 and 45m from shore; we motored at idle speed looking for any evidence of Eurasian water-milfoil's characteristic red growth top. Once we had finished the three transects, we returned to our starting point using a stitch pattern that crossed back and forth over all three lines to look for any plants we may have missed between the transects. As EWM primarily reproduces by shedding numerous vegetative fragments, we also walked along the north landing shoreline to look for pieces of EWM that would likely wash up if plants were present.

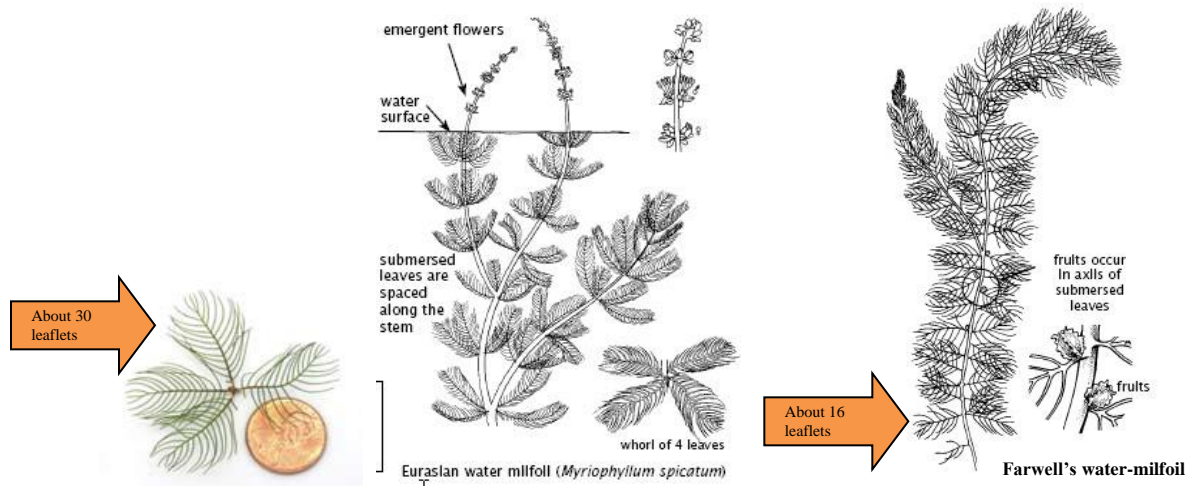
Figure 4: Eurasian and Farwell's Water-milfoil Identification
 (Hill et al. in Maine's Field Guide to Aquatic Invasive Species and Crow and Hellquist 2006)

As in the past, the only native milfoil we found that resembles EWM was Farwell's water-milfoil (*Myriophyllum farwellii*) – a valuable habitat producing native plant that is relatively uncommon in the state. In Pipe Lake, it grows in occasionally dense beds in the sheltered bays of the southeast corner in shallow water over thick organic muck (especially near the old beaver lodge on the east side of the northeast island although even here it was uncommon in 2024). Farwell's is also found scattered through North Pipe Lake, but here it is uncommon and never bed forming. Farwell's water-milfoil can be told from Eurasian water-milfoil in that it has leaves with leaflets numbering <16 whereas EWM normally has >26 leaflets (Figure 4). Although both species can reproduce by shedding rooted fragments, EWM also has an emergent flower stalk where Farwell's flowers are scattered along the stem and look like tiny nuts (Figure 5).

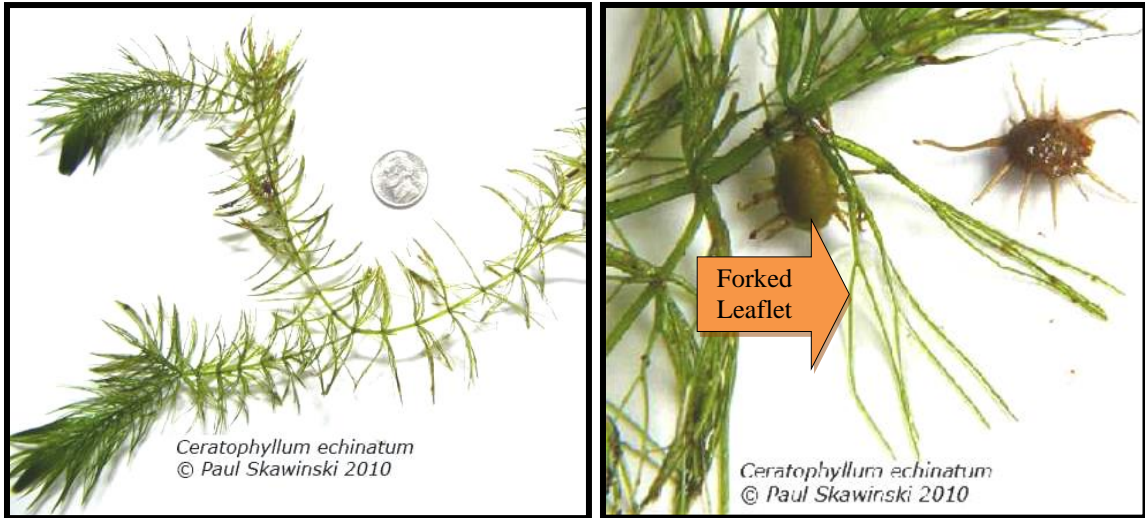
Figure 6: Spiny Hornwort Identification (Skawinski 2010)

We also noted two other beneficial native species that could potentially be confused with Eurasian water-milfoil: Spiny hornwort (*Ceratophyllum echinatum*) (Figure 6) and Common bladderwort (*Utricularia vulgaris*) (Figure 7). Both species are relatively common in the lakes' bays where they primarily occur in water <1.5m over organic muck substrates. Hornwort can be told from the milfoils as it has leaflets that fork repeatedly, while bladderworts have tiny "bladders" along their forked leaflets where these carnivorous plants trap and digest minute aquatic animals like mosquito larvae.

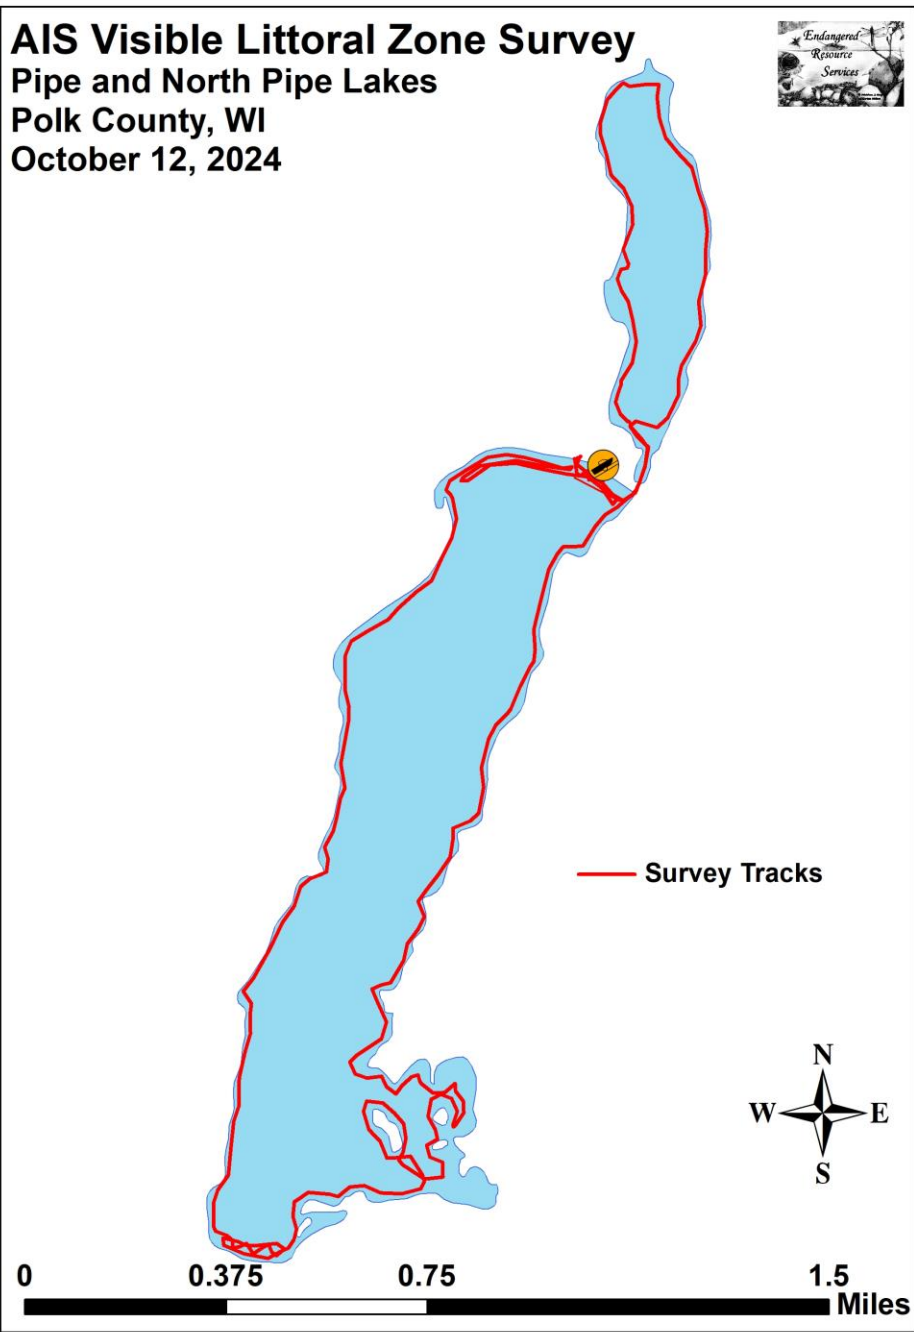
Appendix I: Pipe Lakes Fall Survey Tracks

AIS Visible Littoral Zone Survey
Pipe and North Pipe Lakes
Polk County, WI
October 12, 2024
