**Eurasian Water-milfoil (*Myriophyllum spicatum*)
Boat Landing and Meandering Littoral Zone Surveys
Pipe/North Pipe Lakes - WBIC: 2490500 and 2485700
Polk County, Wisconsin**

Landing Monitoring and Shoreline Surveys

Endangered Resource Services, LLC
Matthew S. Berg, Research Biologist
St. Croix Falls, Wisconsin
June-October, 2017

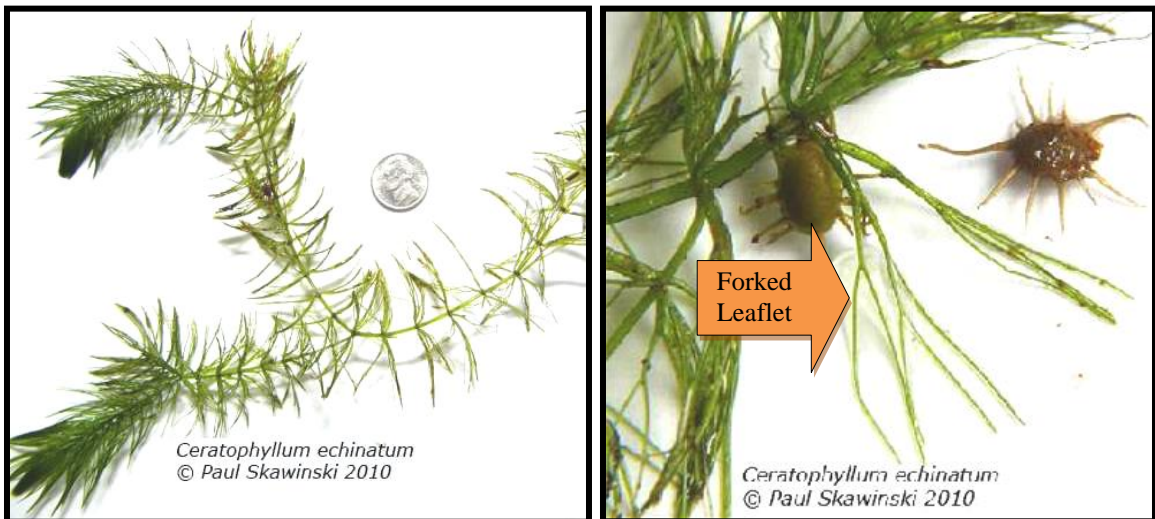
Figure 5: Spiny Hornwort Identification (Skawinski 2010)

We also noted two other beneficial native species that could potentially be confused with Eurasian water-milfoil: Spiny hornwort (*Ceratophyllum echinatum*) (Figure 5) and Common bladderwort (*Utricularia vulgaris*) (Figure 6). Both species are relatively common in the lakes' bays where they primarily occur in water <1.5m over organic muck substrates. Hornwort can be told from the milfoils as it has leaflets that fork repeatedly, while bladderworts have tiny "bladders" along their forked leaflets where these carnivorous plants trap and digest minute aquatic animals like mosquito larvae.

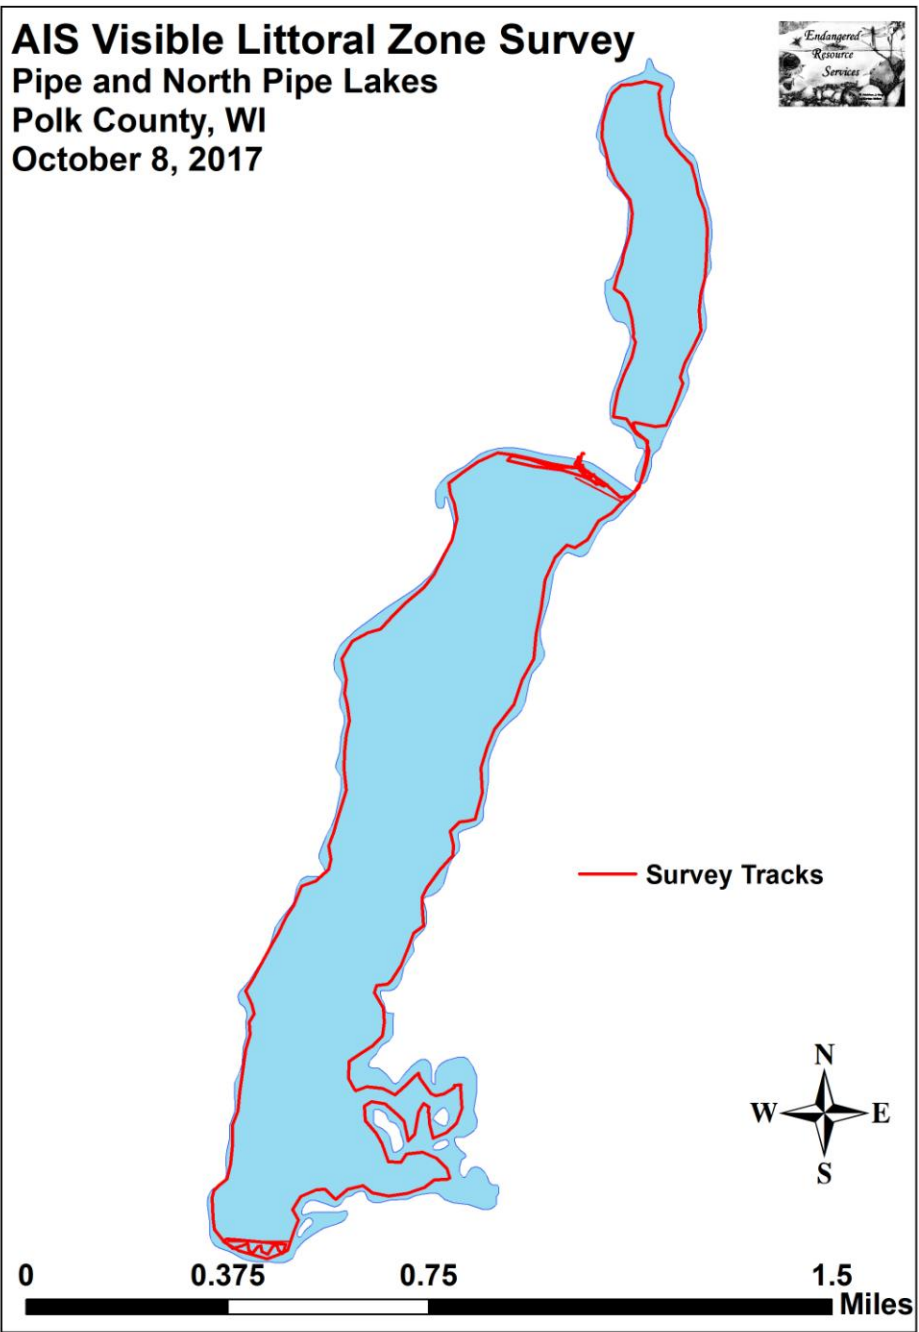
Appendix I: Pipe Lakes October Survey Tracks

AIS Visible Littoral Zone Survey
Pipe and North Pipe Lakes
Polk County, WI
October 8, 2017
